Big River
(Valentine Creek to Headwaters)

County: Mendocino

T 17N R 17W Sec 29

HEADWATERS OF BIG RIVER

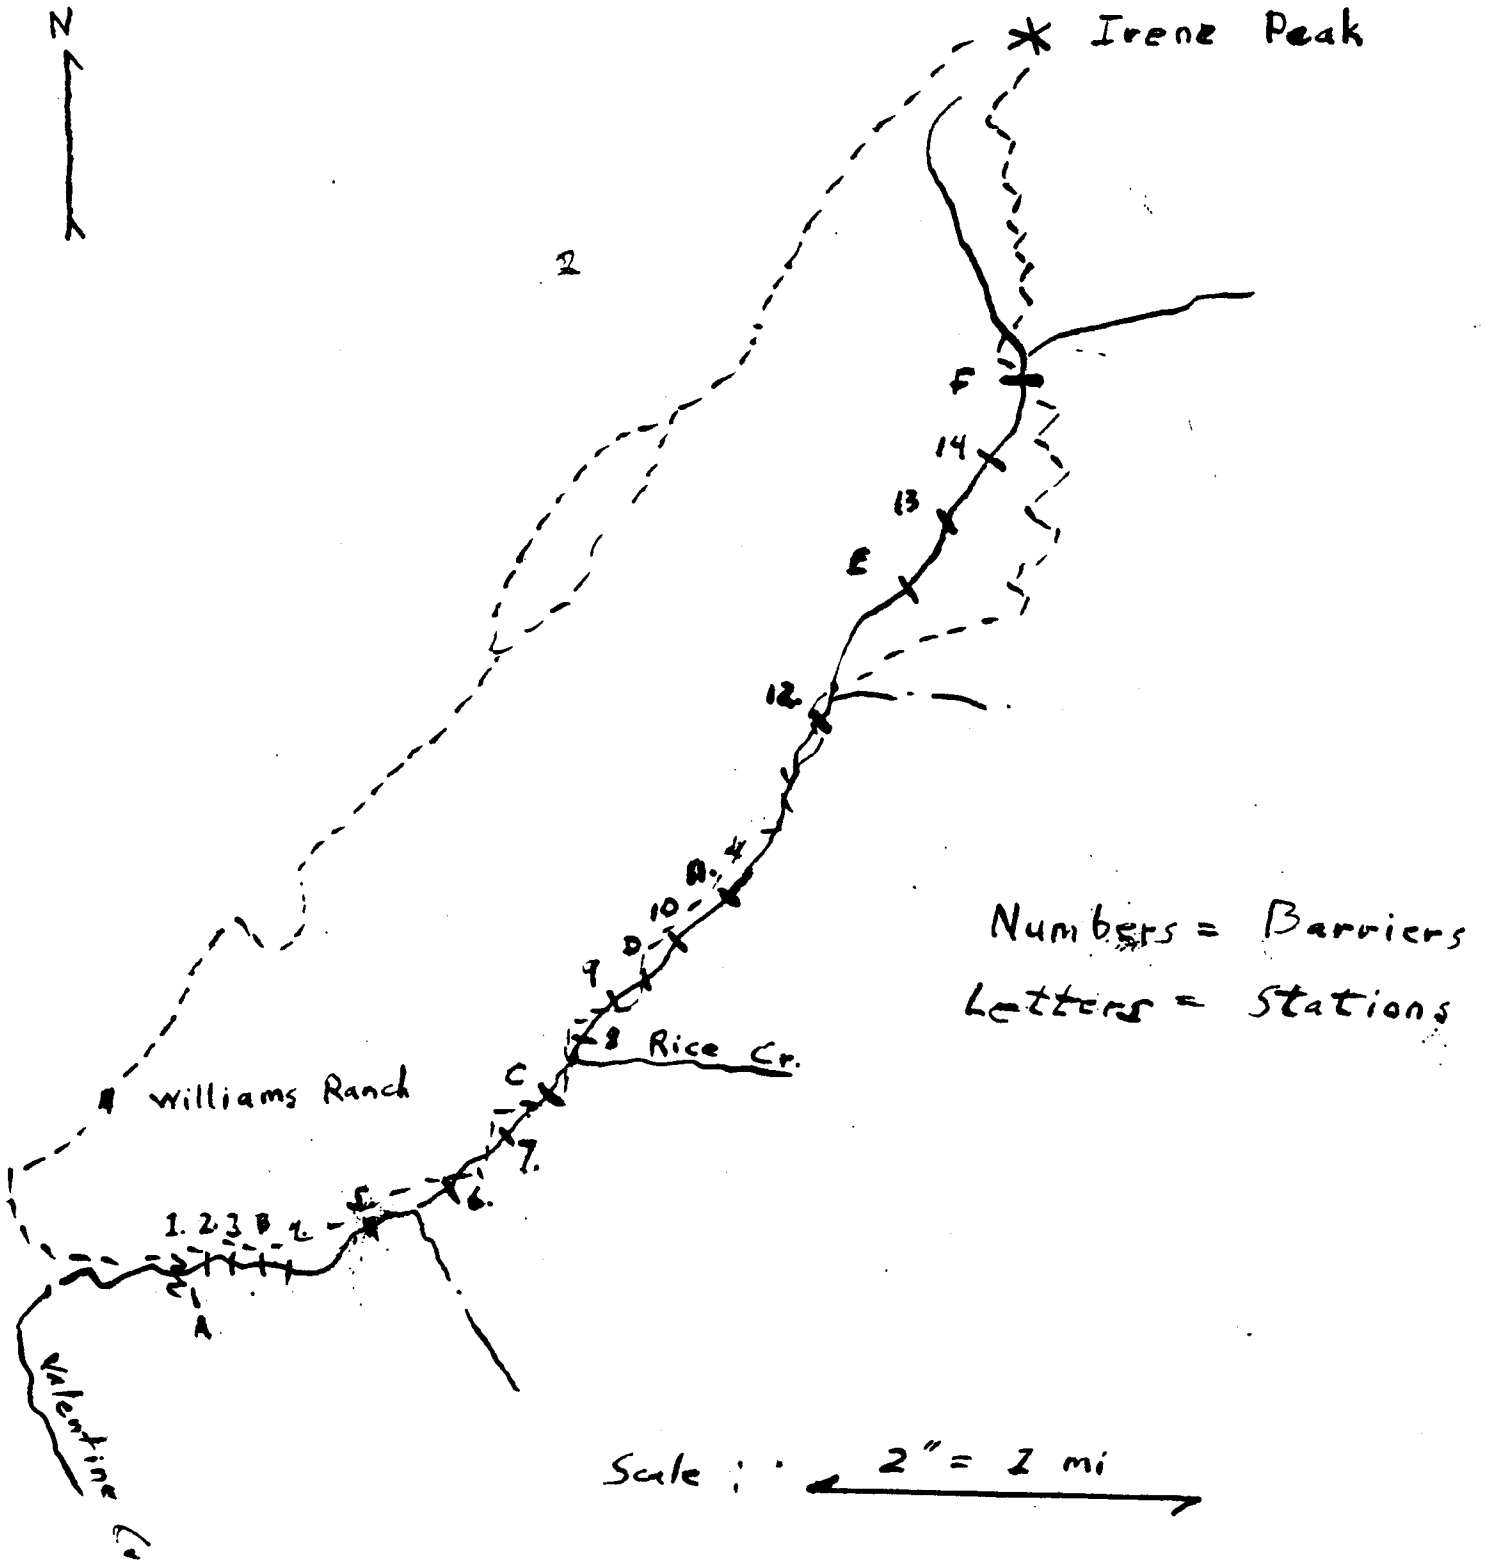
1. An old flush dam located about one mile above the mouth of Valentine Creek. 120ft long, 40ft high, complete barrier 14ft drop in streambed.
2. Log jam - located at the base of the upstream side of #1. 90ft long, 20ft wide, 15ft high, void area 92%.

3. Log jam - located .1 mile upstream from #1. 75ft long, 50ft wide, 3ft high, void area 50%.
4. Log jam - debris located .3 mile upstream from #1. 90ft wide, 35ft long, 15ft high, 70% voided area.

5. Log jam - debris located .4 mile upstream from #1. 85ft long, 40 ft wide, 7ft high, 65% void.
6. Log jam located .1 mile upstream from #5. 40ft long, 30ft wide, 7ft high, 40% void.

7. From #6 to mouth of Rice Creek. .1 mile scattered debris and slash - no estimate.
8. Log jam - just above mouth of Rice Creek. 30ft long, 35ft wide, 7ft high, 65% void.

9. Immediately above #8, four average logs - jam (cut logs).
10. Log jam .1 mile upstream from Rice Creek. 100ft long, 30ft wide, 6ft high, 96% void.
11. Log jam - .2 mile above Rice Creek. 30ft long, 20ft wide, 4ft high, 50% void.

12. Log jam - barrier - .4 mile above Rice Creek silted in. 35ft long, 35ft wide, 6ft high, 90%void. Difference in streambed level - 4 to 5ft.
13. Boulder - log jam - barrier - located .3 mile upstream from #12. 8ft long, 29ft wide, 6ft high, 50% void. Difference in streambed level 4ft. 40% boulder 10% log.

14. Log and dirt filled jam and barrier -creek crossing - located .2 mile up from #13. No culvert - difference in stream bed level - 5ft.
