TO: A. GRASS
FROM: M. KIDD
DATE: JUNE 1, 1983

RE: NORTH FORK OF SOUTH FORK OF NOYO

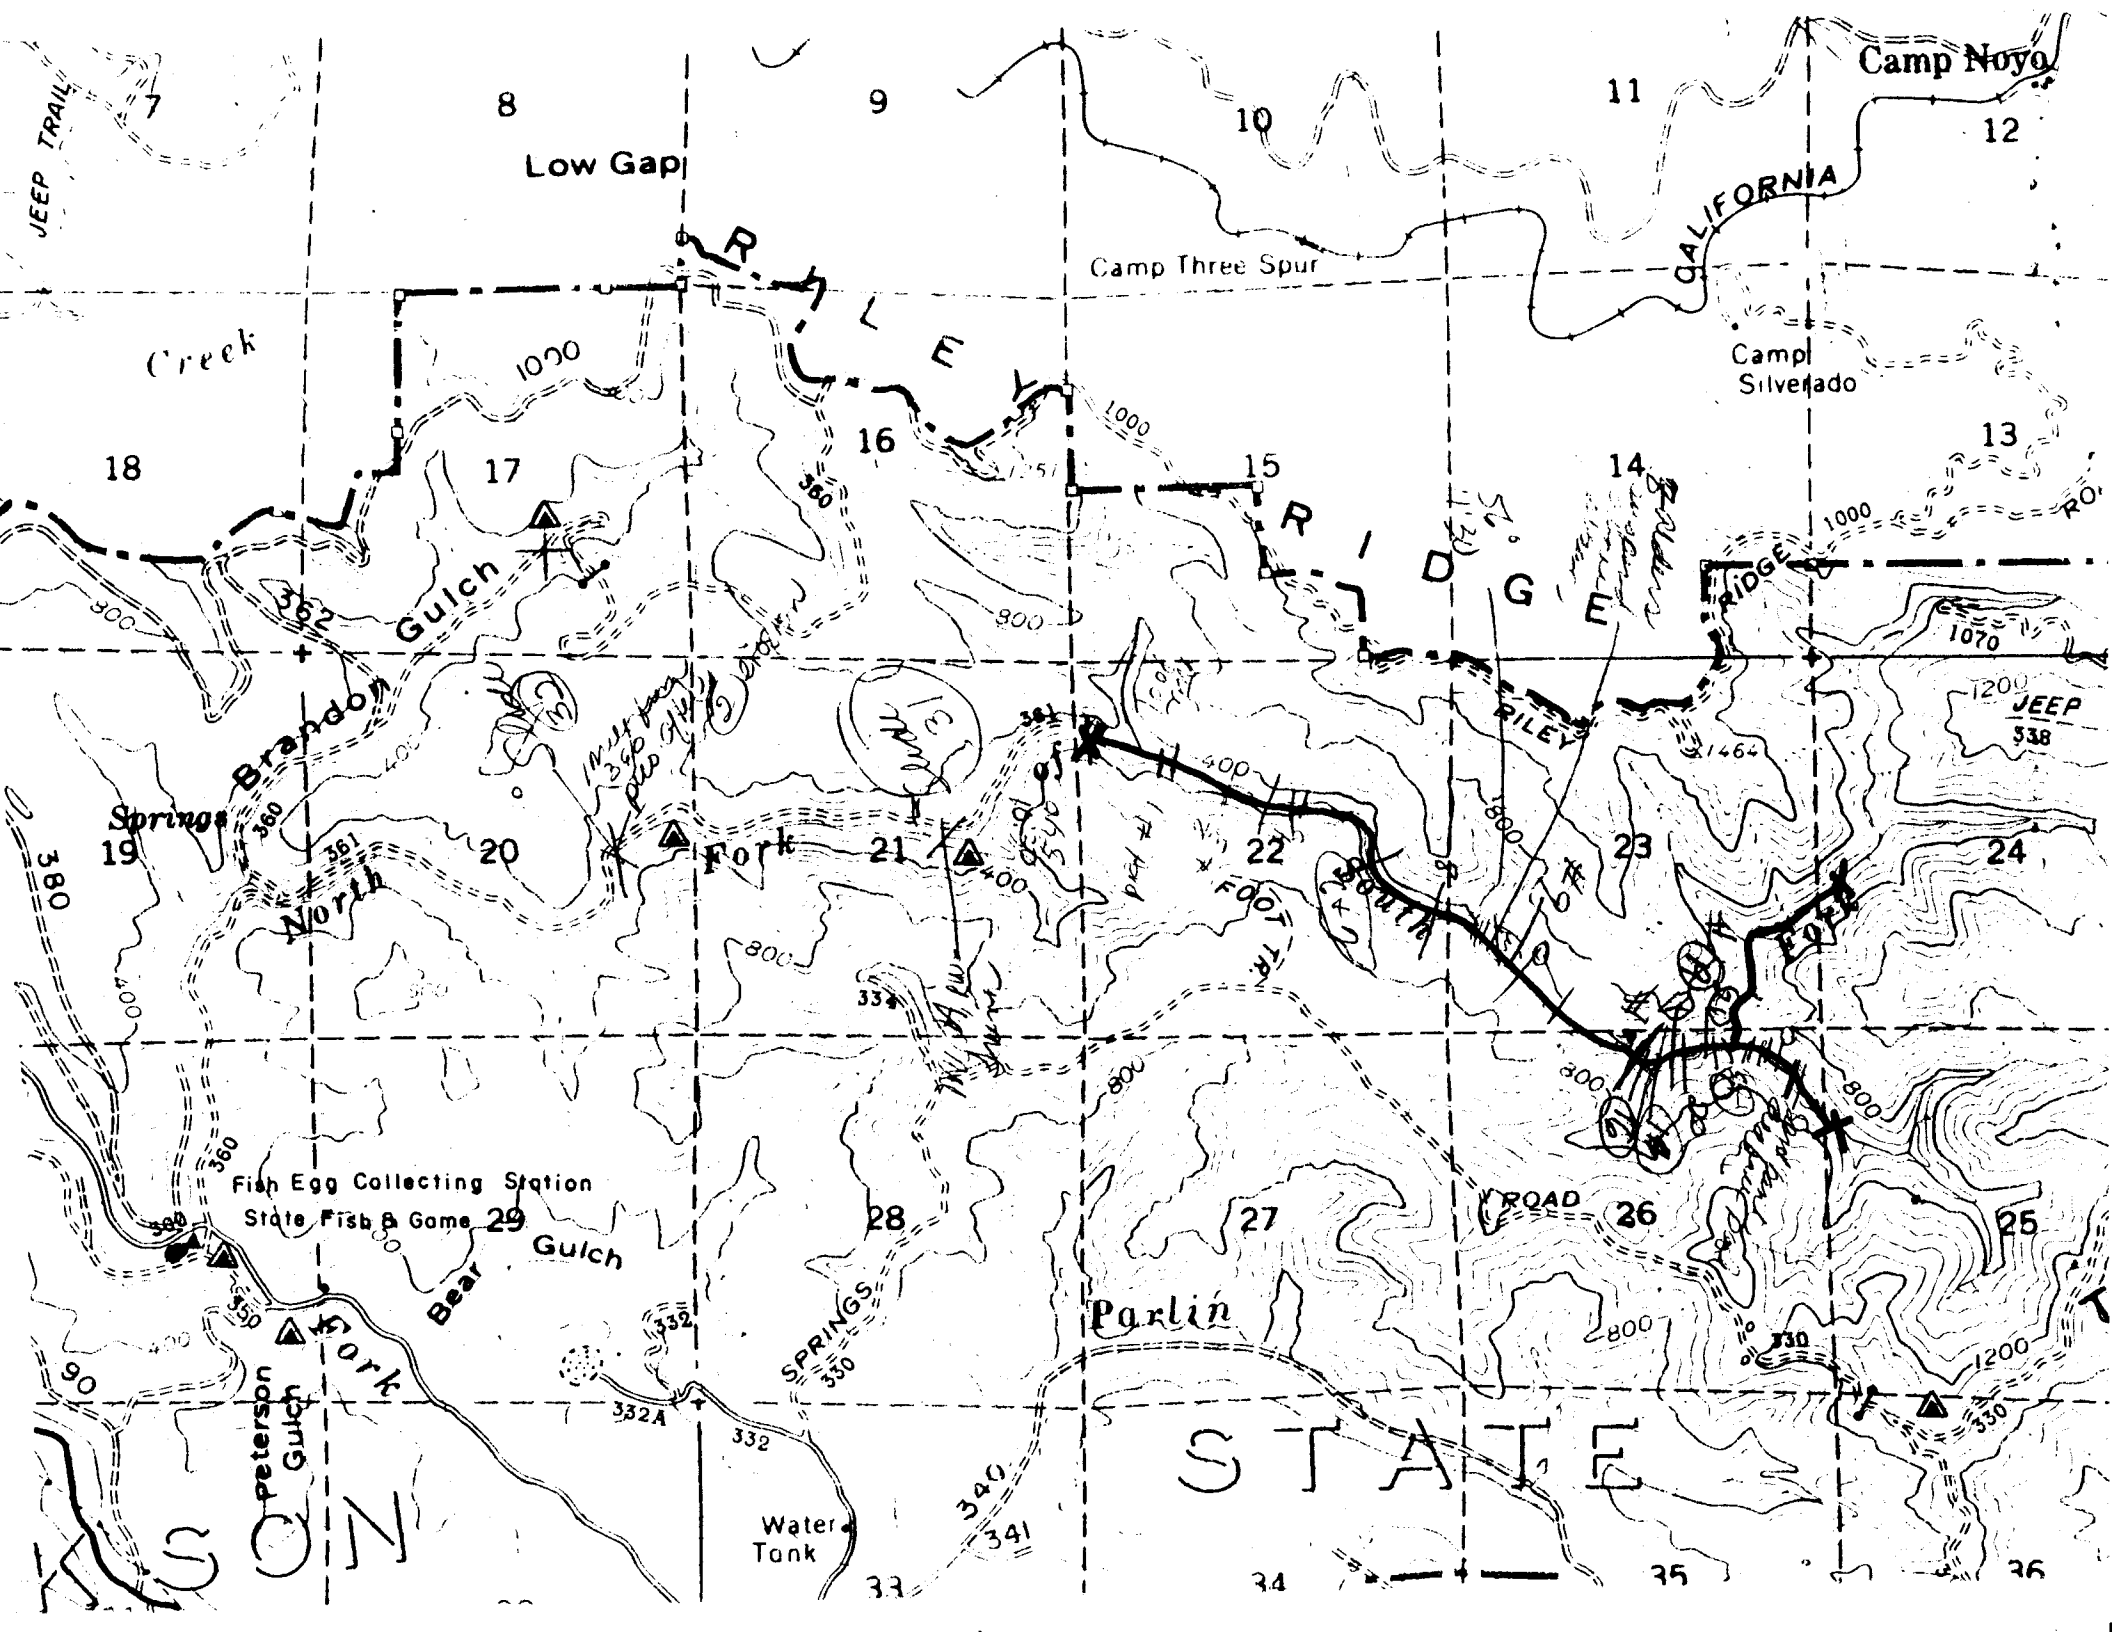
Slides 31 and 32 were taken from road 361. I have indicated there location on the map.
