CALIFORNIA DEPARTMENT OF FISH AND GAME

**STREAM SURVEY**

NAME..... PIG PEN GULCH..... COUNTY... Mendocino.....

STREAM SECTION..... FROM... mouth..... TO... extreme headwaters... LENGTH... 1-3/4.....

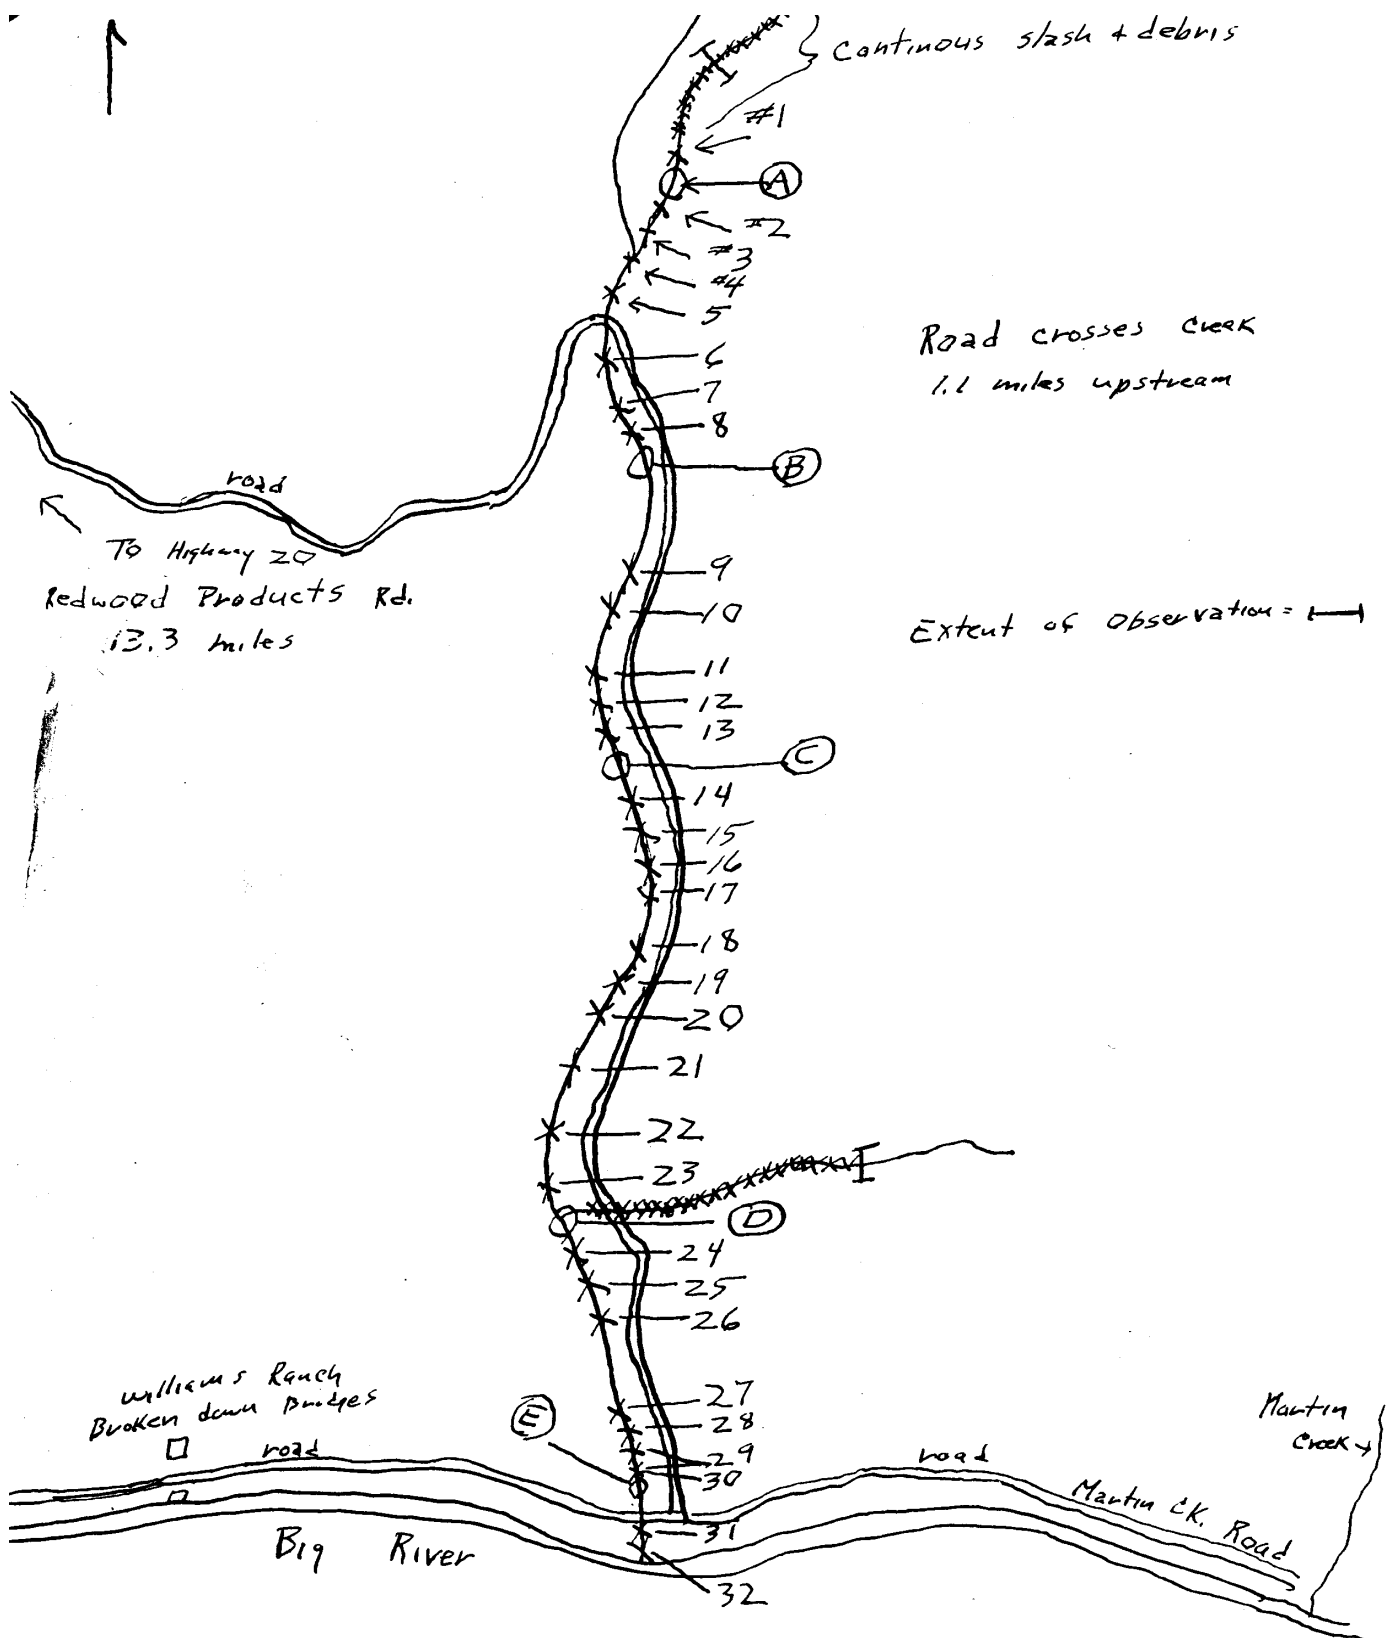
SKETCH MAP - See attached.

Continuous slash + debris

Road crosses creek  
1.1 miles upstream

Williams Ranch  
Broken down bridges
