# New Growth Forestry

December 15, 1988

Re: THP 1-88-743MEN

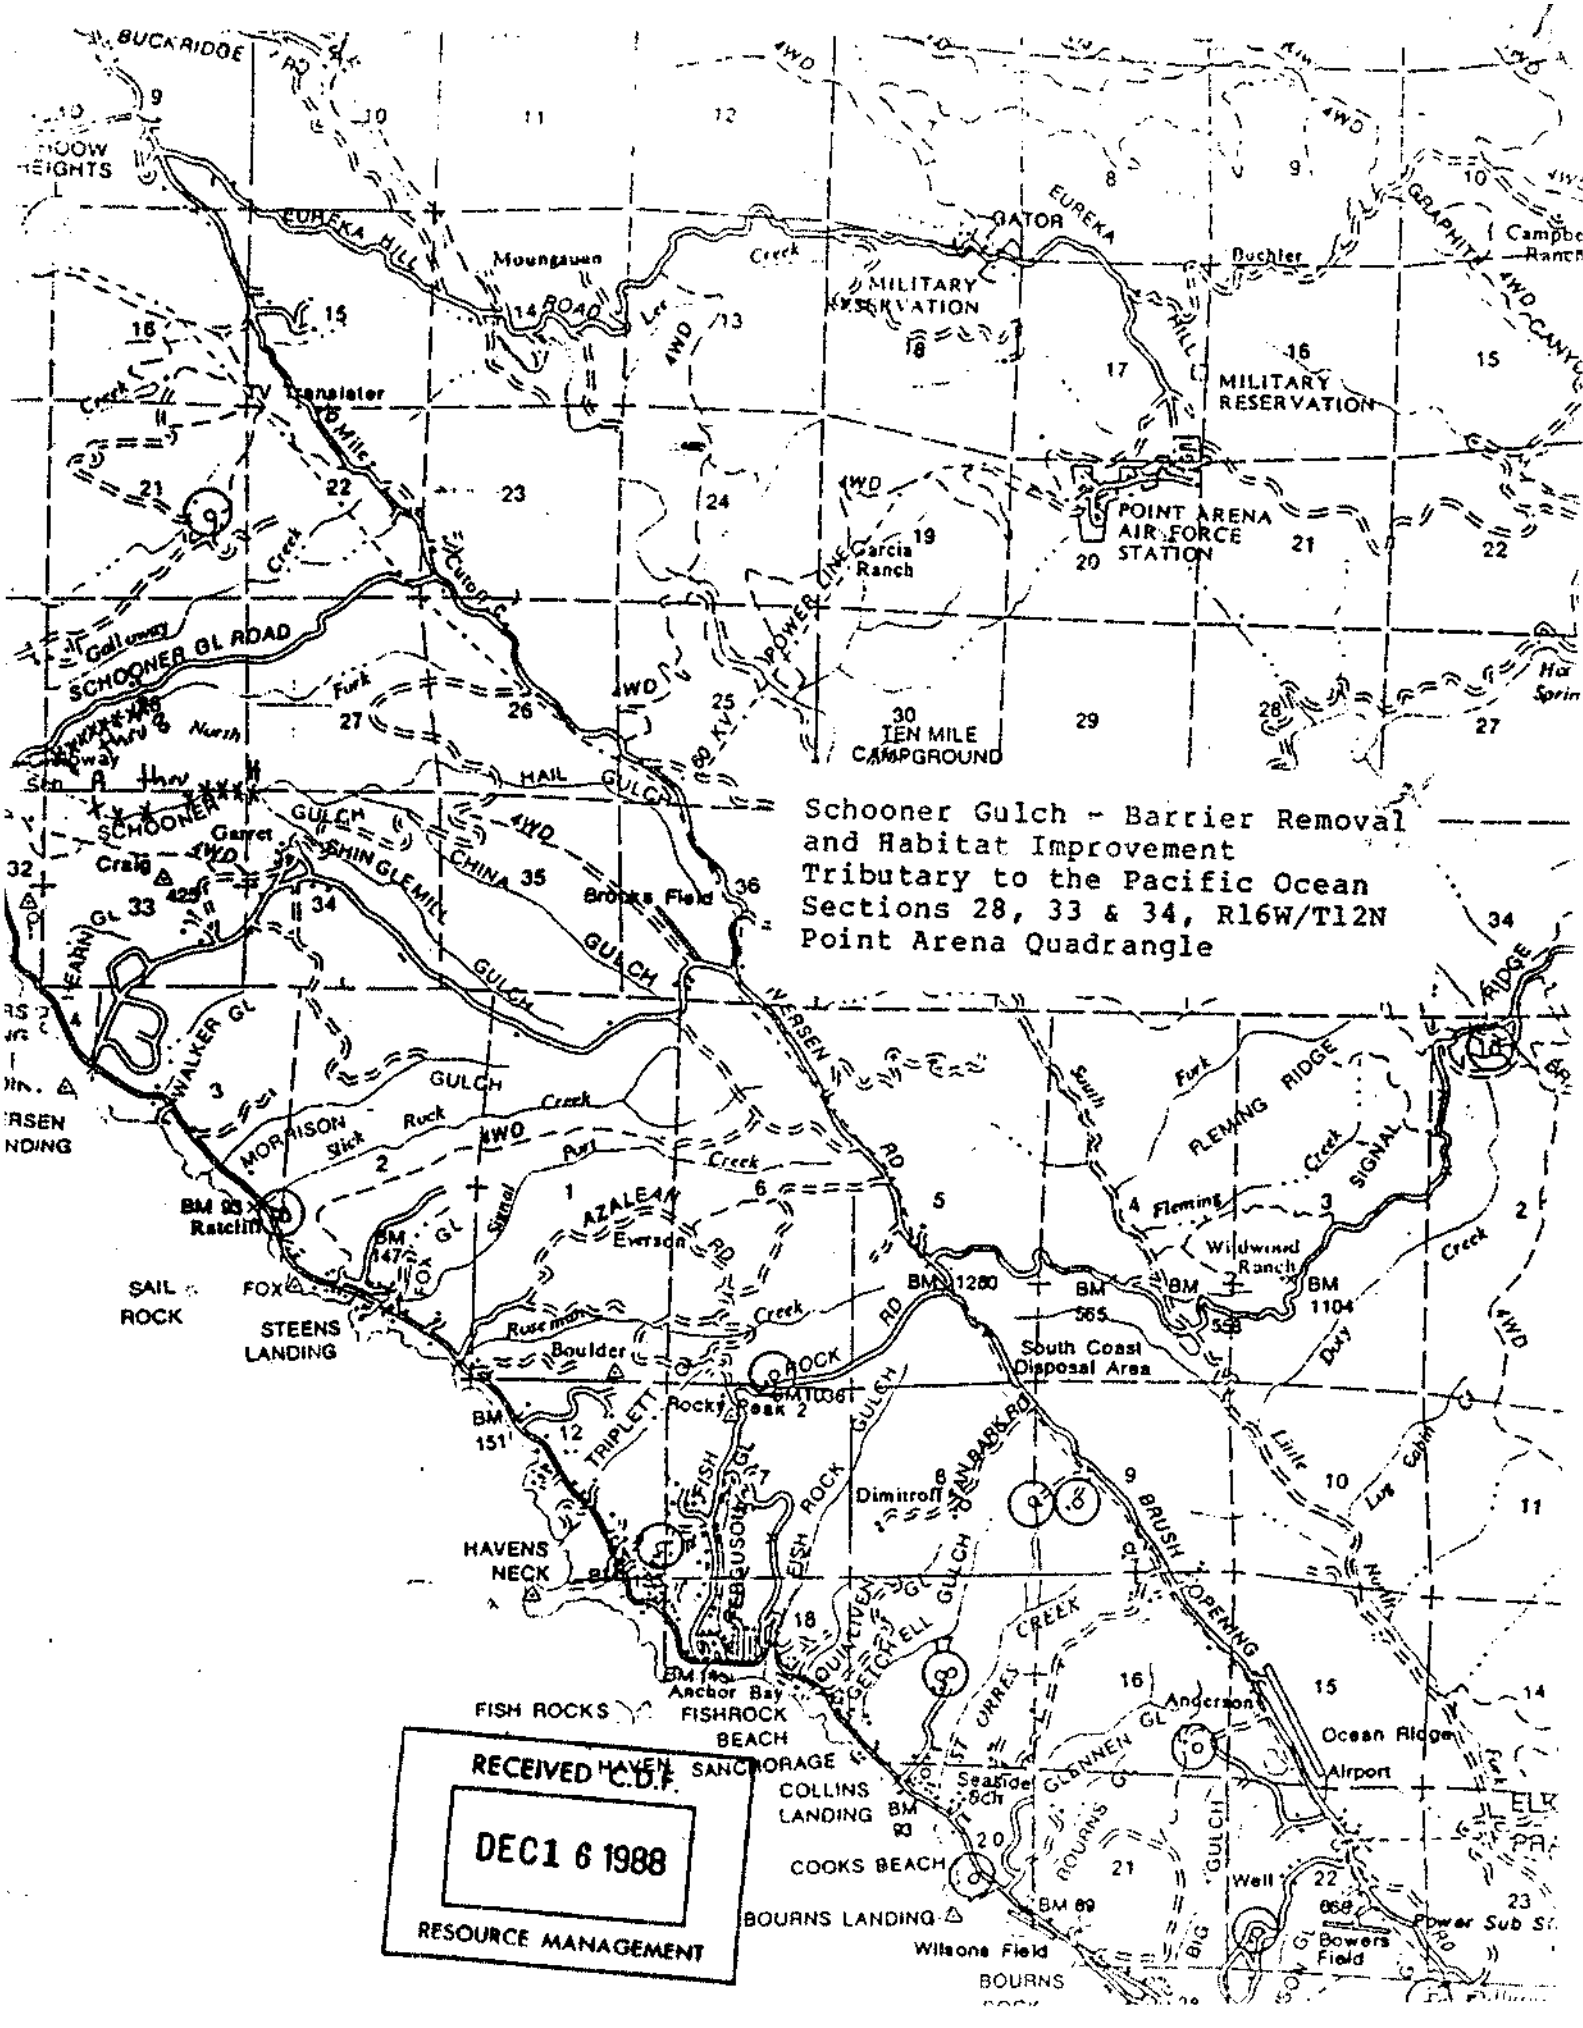
Schooner Gulch - Barrier Removal  
and Habitat Improvement  
Tributary to the Pacific Ocean  
Sections 28, 33 & 34, R16W/T12N  
Point Arena Quadrangle

The disruption of the gravel transport process in Schooner Gulch as a result of debris jams as shown at Locations "A" through "H" on the attached map has built up gravel impoundments 3 to 6 feet deep at most of the sites and generally stopped the movement and associated cleaning process of the gravels in the section of Schooner Gulch below Shinglemill Gulch. Fine sediments moving down from upstream have settled out into the stationary gravels

and the pools in this section of Schooner Gulch to such a degree that the ability of the creek to provide the spawning and rearing habitat necessary for a run of steelhead has reached a critical level.

Until these debris jams are removed and the gravel transport process of Schooner Gulch resumes, there will likely be a worsening problem from fine sediment deposition. Currently, there is no funding allocated by the Department of Fish and Game for the restoration proposal New Growth Forestry has submitted to the DF&G for removing these jams. While the jams remain in place, any increase to the existing sedimentation that may come from ongoing and future logging will add to an already serious problem. It is reasonable to expect that there will be at least a short-term addition of sediment from ground disruptions associated with tractor logging operations currently in process and proposed in this plan.
