# **ELEMENTS OF RECOVERY**

**An Inventory of Upslope Sources  
of Sedimentation in the  
Mattole River Watershed**

**Rehabilitation Prescriptions**

**December 1989**

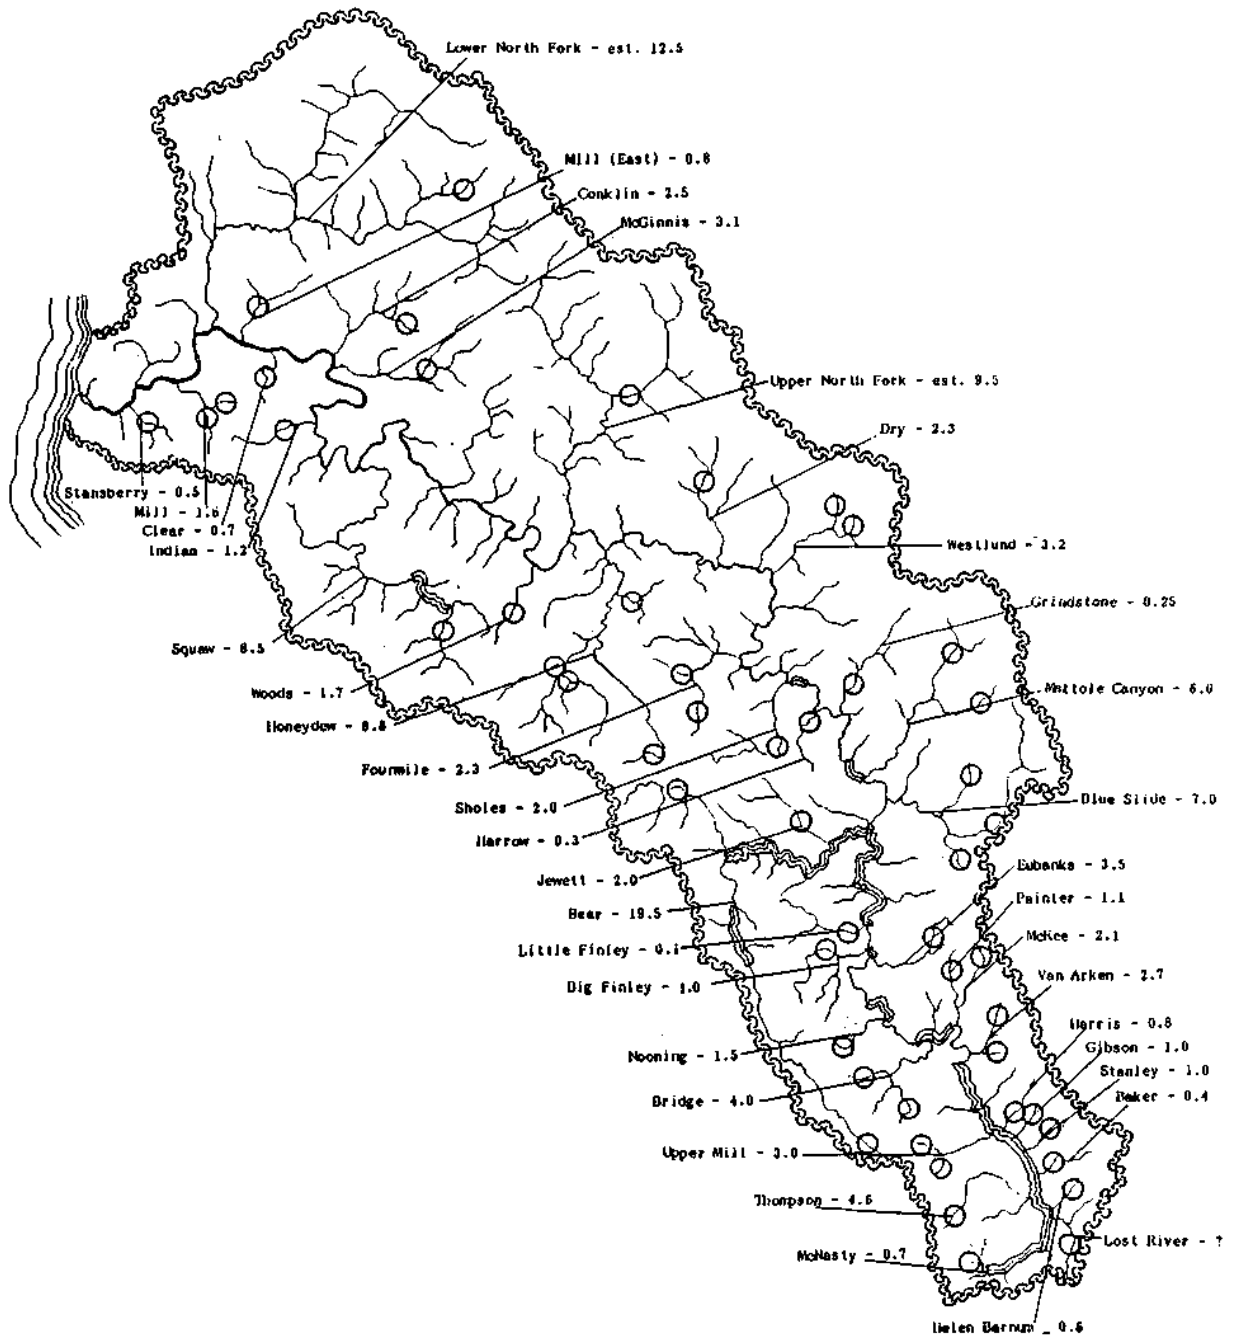
# SALMONID HABITAT Of the MATTOLE RIVER and its TRIBUTARIES

This is a summary of known use of habitat by salmonids in the tributaries of the Mattole. Information on king salmon spawning habitat is based on nine years of spawning surveys by the Mattole Watershed Salmon Support Group. Circle notations on the watershed map are an estimation of the upstream limit of the use of that stream by any Mattole salmonid: king salmon, silver salmon, or steelhead. These notations are sometimes based on a physical barrier such as a bedrock falls or a semi-permanent logjam, and sometimes on a single "most upstream" observation made by a surveyor or other resident. Numerals next to creek names refer to stream miles of known salmonid habitat in each creek. These estimations are based on findings from the *Mattole Survey Program, August 1981 – August 1982*, conducted by the Coastal Headwaters Association, and are augmented by observations of surveyors made during the course of the current survey.

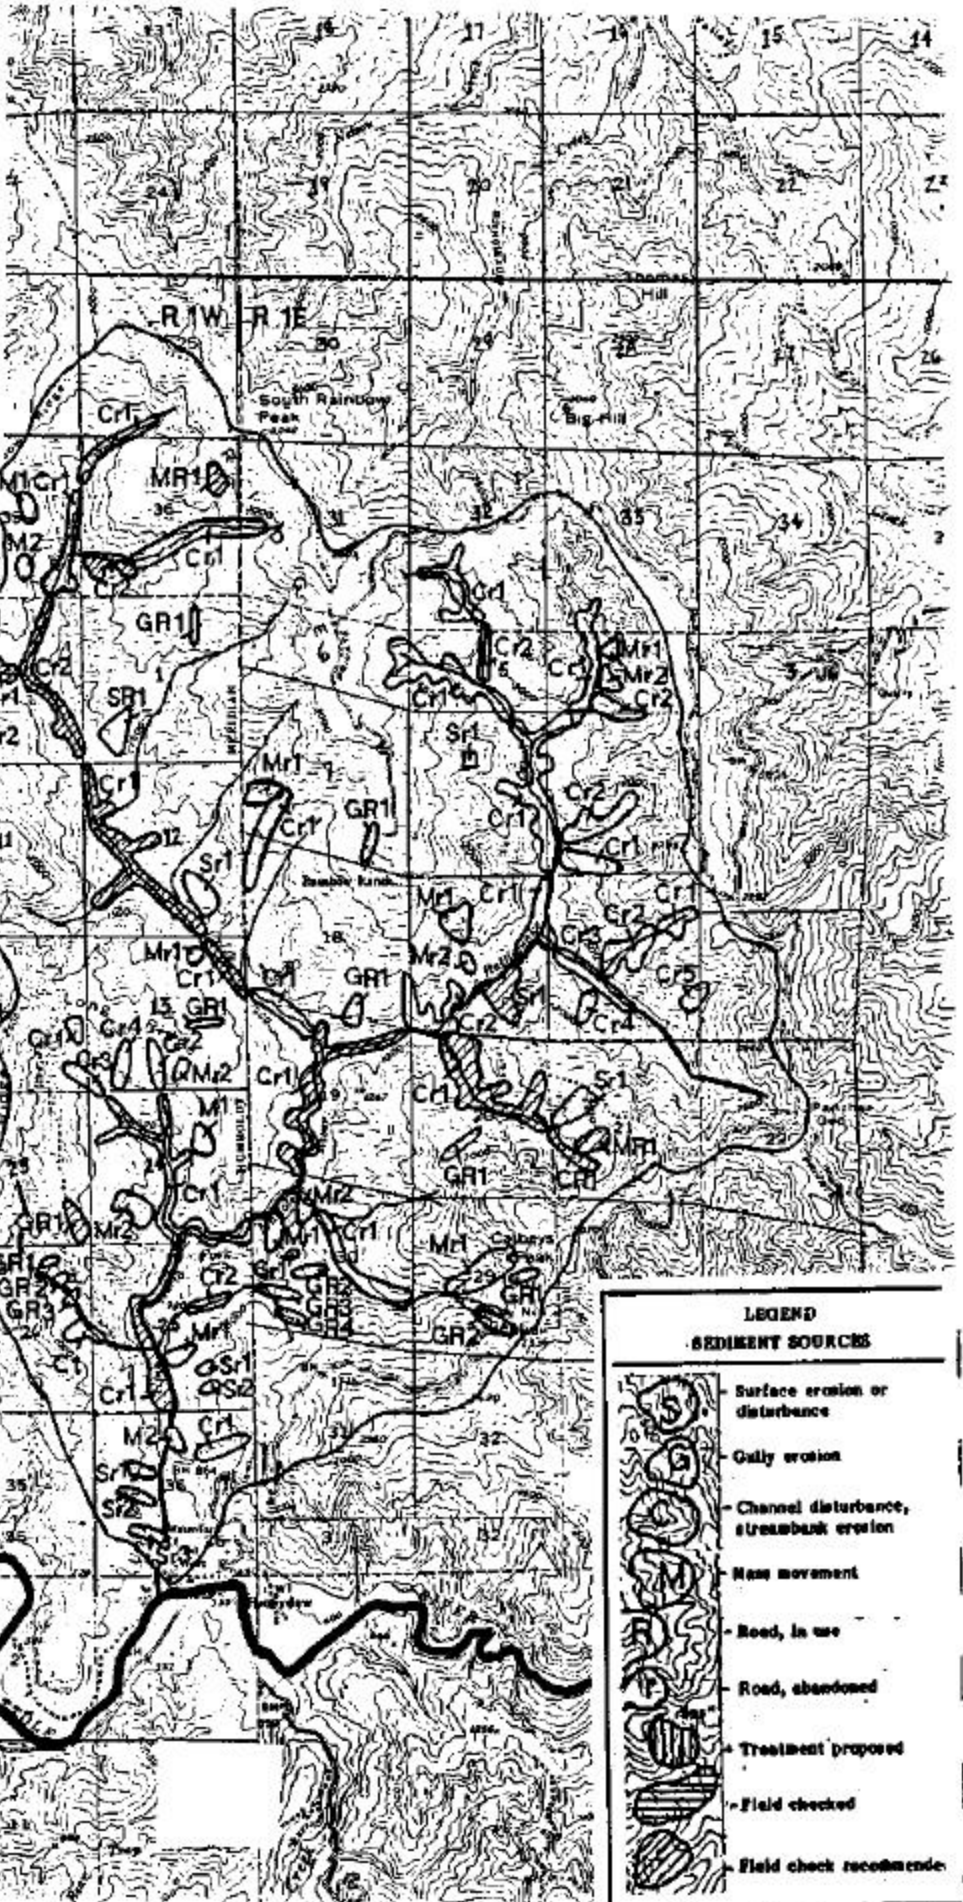
DRAINAGE AREA X

LEGEND	
SEDIMENT SOURCES	
	Surface erosion or disturbance
	Gully erosion
	Channel disturbance, streambank erosion
	Mass movement
	Road, in use
	Road, abandoned
	Treatment proposed
	Field checked
	Field check recommended
