TO: A. GRASS
FROM: M. KIDD
DATE : JUNE 14, 1983
RE: BOOTH GULCH (Trib. Middle Fork of Ten Mile)

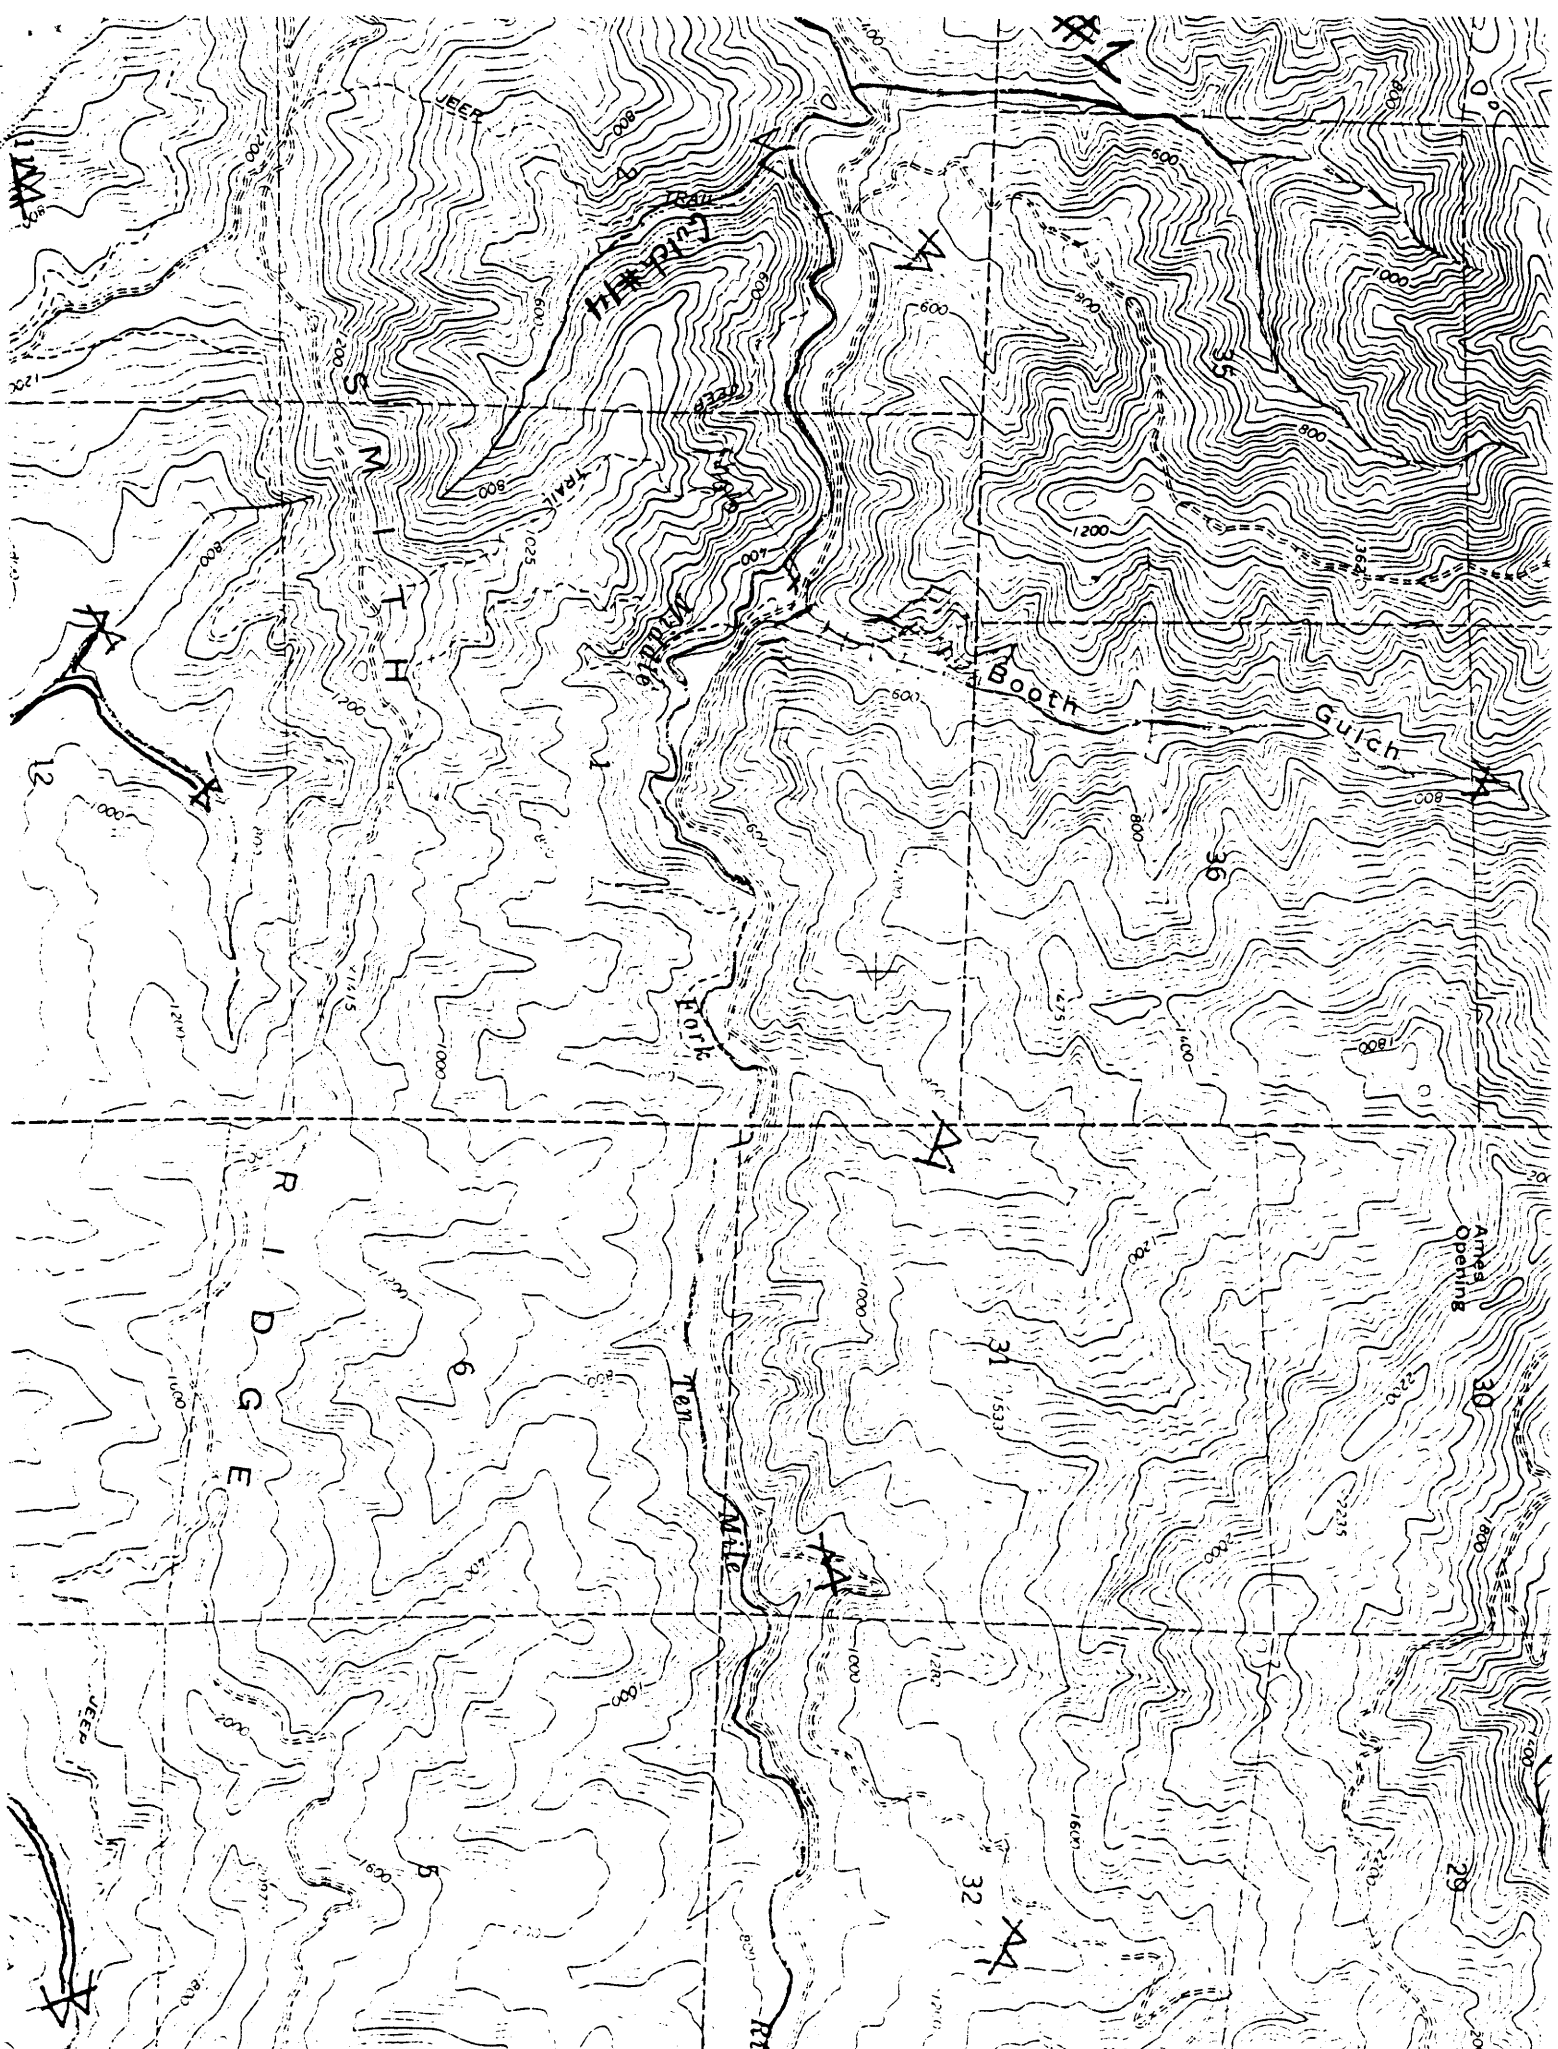
Walked from mouth to Mendo. Fisheries Program # 15.
Mouth is open.

1) (MFP#1) This barrier has blow out and there is no passage problem.

2) Could be a complete blockage:10x50. There is a high gravel and sand buildup. Barrier is created by an old stump in creek collecting debris.

3) Located just upstream from road: large pool with pile of debris in and along side of creek. It is not blocking passage at this time.

4) Barrier 25 x 25 with a 10' buildup of gravel and sediment. Most of small debris is cutup material washed downstream. There are approx. 12 logs.

5) Jam immediately upstream. There is a large amount of debris and logs. Stream has cut new path around barrier, 75' x 30' with an 8' buildup of gravel and sediment. There is possible salvage at this site.

6) Lots of imbedded material: 125'x30 with a 16' buildup of gravel and sediment. Creek cut new channel into bank.

7) Barrier-Rootball collecting debris. 15'x15' with a 9' buildup of gravel and sediment.

8) Sm. debris and 3 logs are accumulating, This area is bedrock with boulder banks.

There is a nice flow to this creek and young of year were spotted below Jam 5. At MFP# there is an erosion problem, possibly blocking a road that parallels the creek on the West side. There is a possibility that it could be repaired and mechanical removal could be used upstream.
