THE RESOURCES AGENCY OF CALIFORNIA
CALIFORNIA DEPARTMENT OF FISH AND GAME
STREAM SURVEY

File form No _____ Date: September 15, 1976NAME: MILLERTON CREEK COUNTY: MarinSTREAM SECTION: _____ FROM: 0.4 mile downstream TO: mouth LENGTH: 2.2 miles
from headwatersTRIBUTARY TO: Tomales Bay TWP: _____ R: _____ SEC: _____OTHER NAMES: Millerton Gulch RIVER SYSTEM: Millerton CreekSOURCES OF DATA: Personal observations

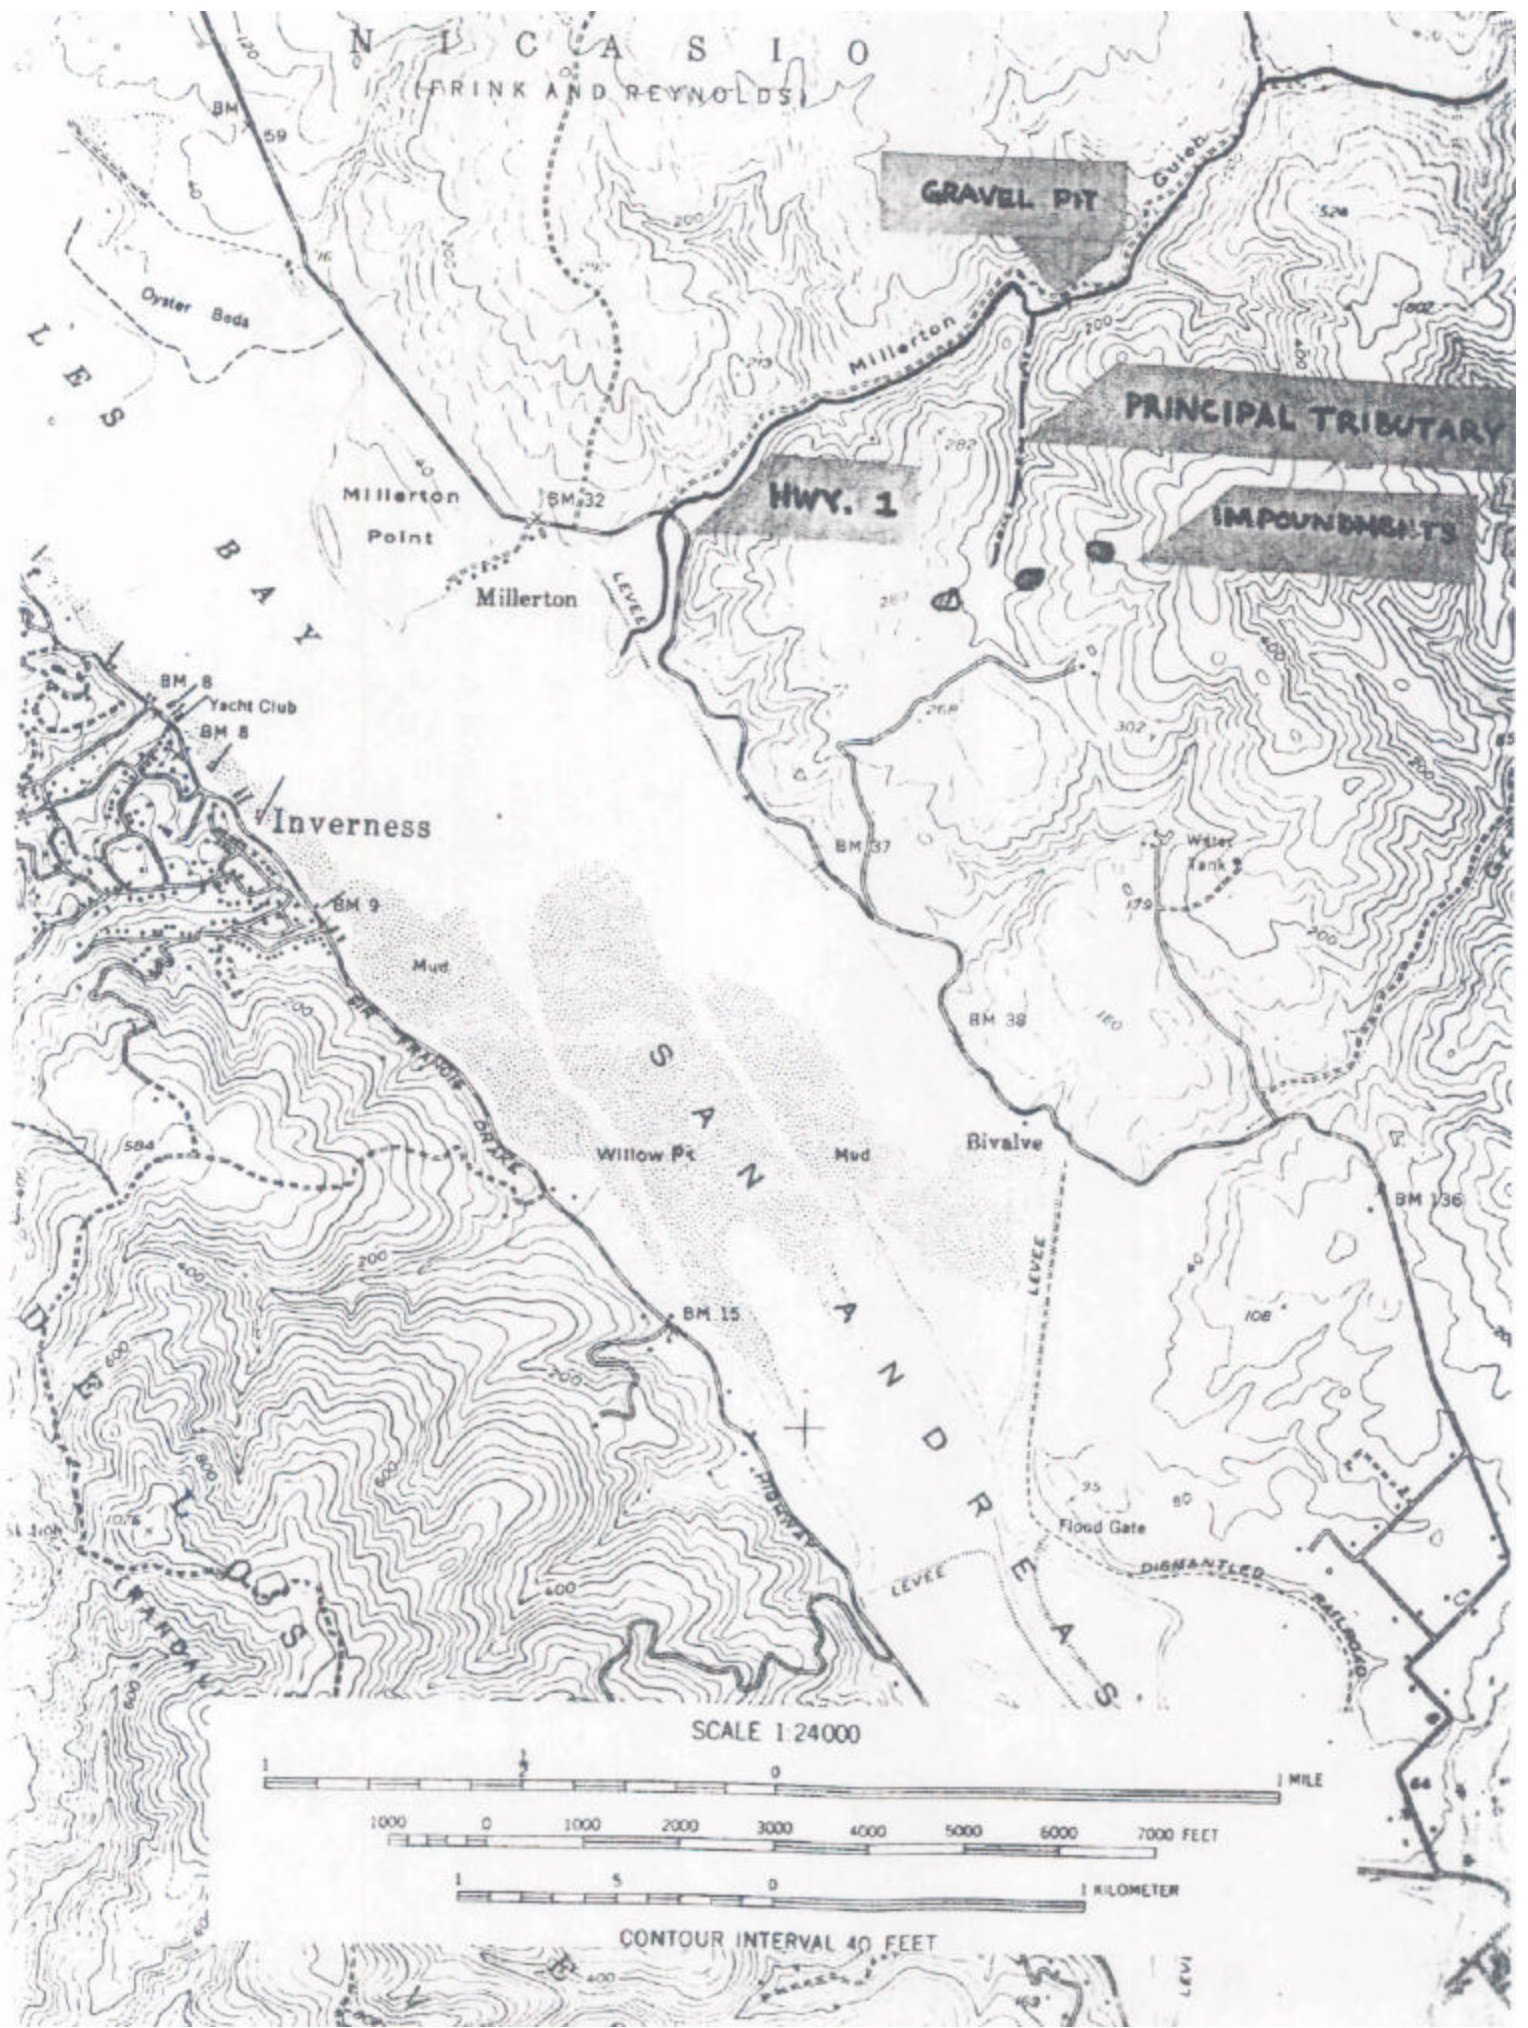
N I C A S I O
(FRINK AND REYNOLDS)

GRAVEL PIT

Pollution - No discharge or litter was observed in the creek itself, but a gravel pit which is currently in operation (see reference map) may contribute to pollution of the stream. Litter such as junked cars and other debris was also observed in a flat, grassy area adjacent to the stream bank.

REFERENCES AND MAPS - U.S.G.S. 15' quadrangle maps: Point Reyes and Inverness.
