Freshwater Creek Watershed Analysis Final Report

**Pacific Lumber Company (PALCO)
Scotia, CA**

Watershed Professionals Network

December 2003

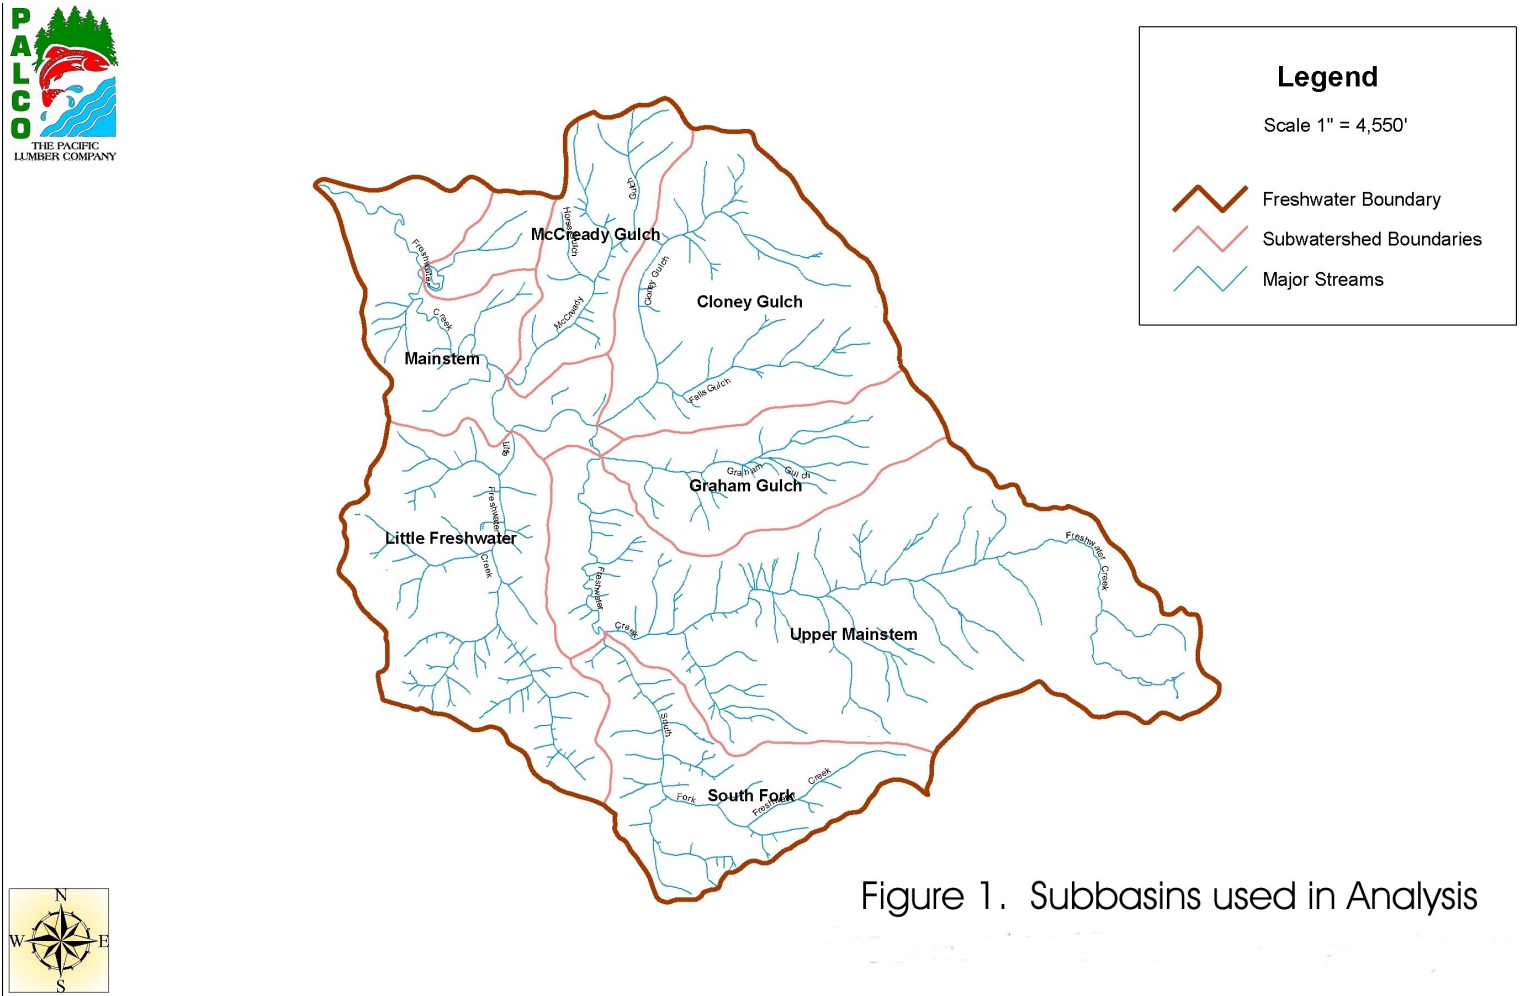
Figure 1. Subbasins used in Analysis

In consultation with the hydrology and stream channel analyst, eight sub-basins were selected within the Freshwater Watershed to localize the study of watershed processes. These sub-basins correspond to the major tributaries, and include Upper Freshwater, South Fork Freshwater, Little Freshwater, Graham Gulch, Cloney Gulch, McCready Gulch, School Forest, and Lower Freshwater (Figure 1).

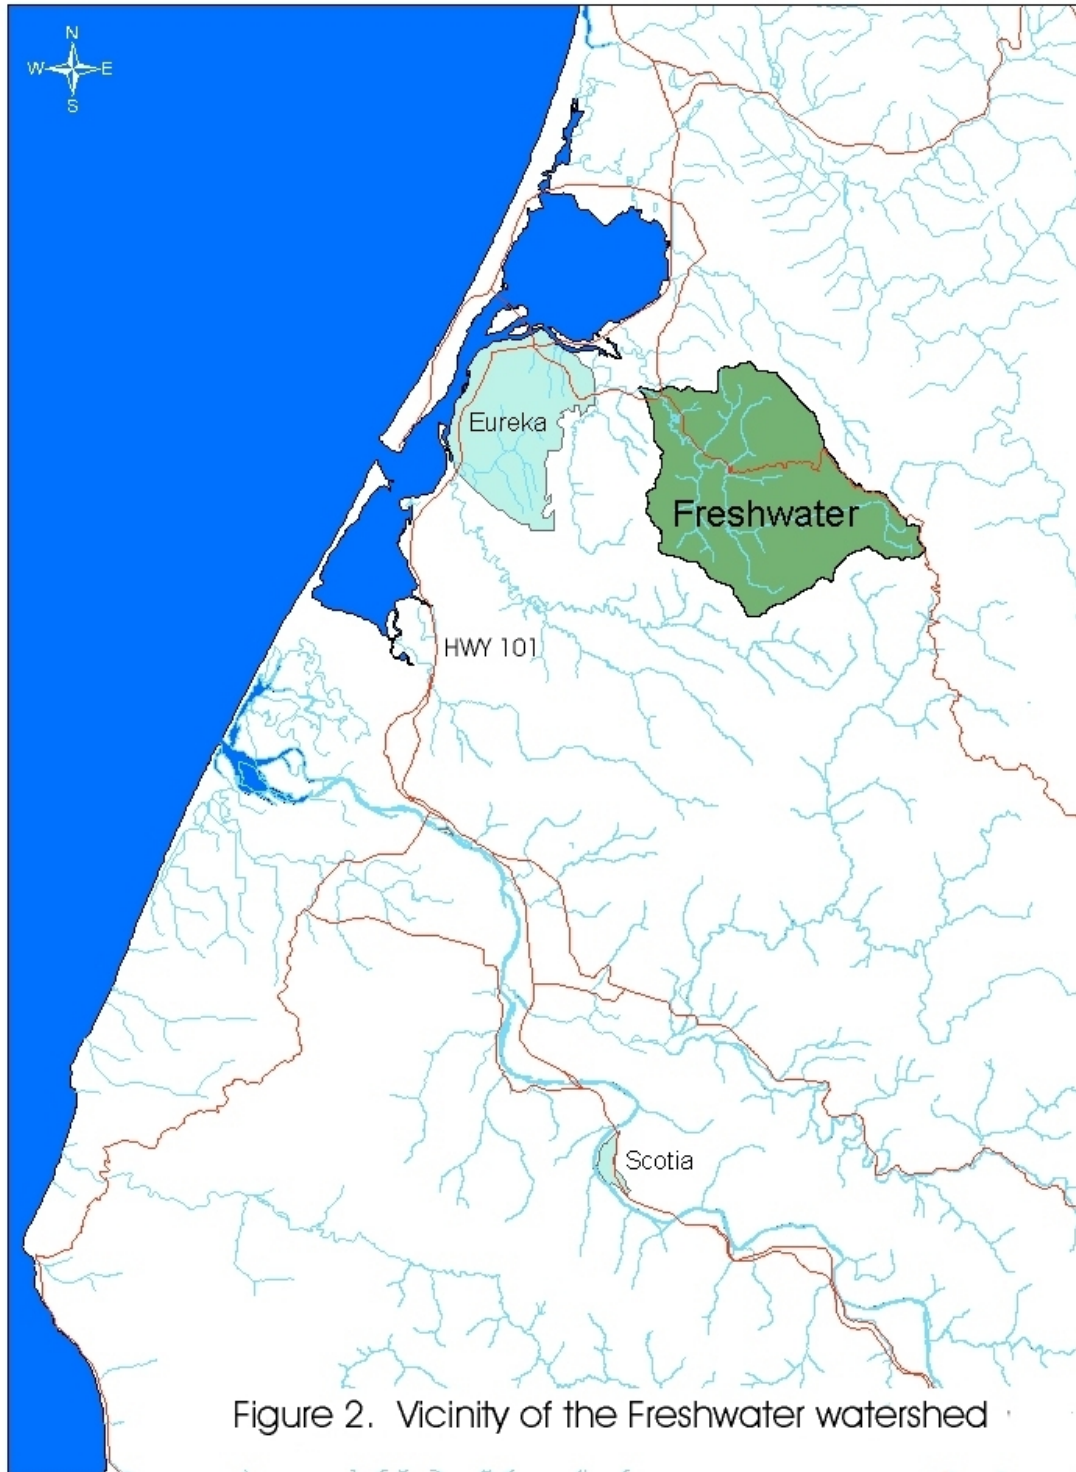
Figure 2: The vicinity of the Freshwater Watershed.

The Freshwater Creek watershed is a 31-mi² drainage basin located approximately 5 miles east of Eureka, California in Humboldt County (Figure 2). Freshwater Creek drains into Humboldt Bay through the Freshwater and Eureka Sloughs at the north end of Eureka. Freshwater Creek is the primary stream flowing through the basin. Major tributaries of Freshwater Creek include Cloney Gulch, South Fork Freshwater Creek, Little Freshwater Creek, McCready Gulch, and Graham Gulch.

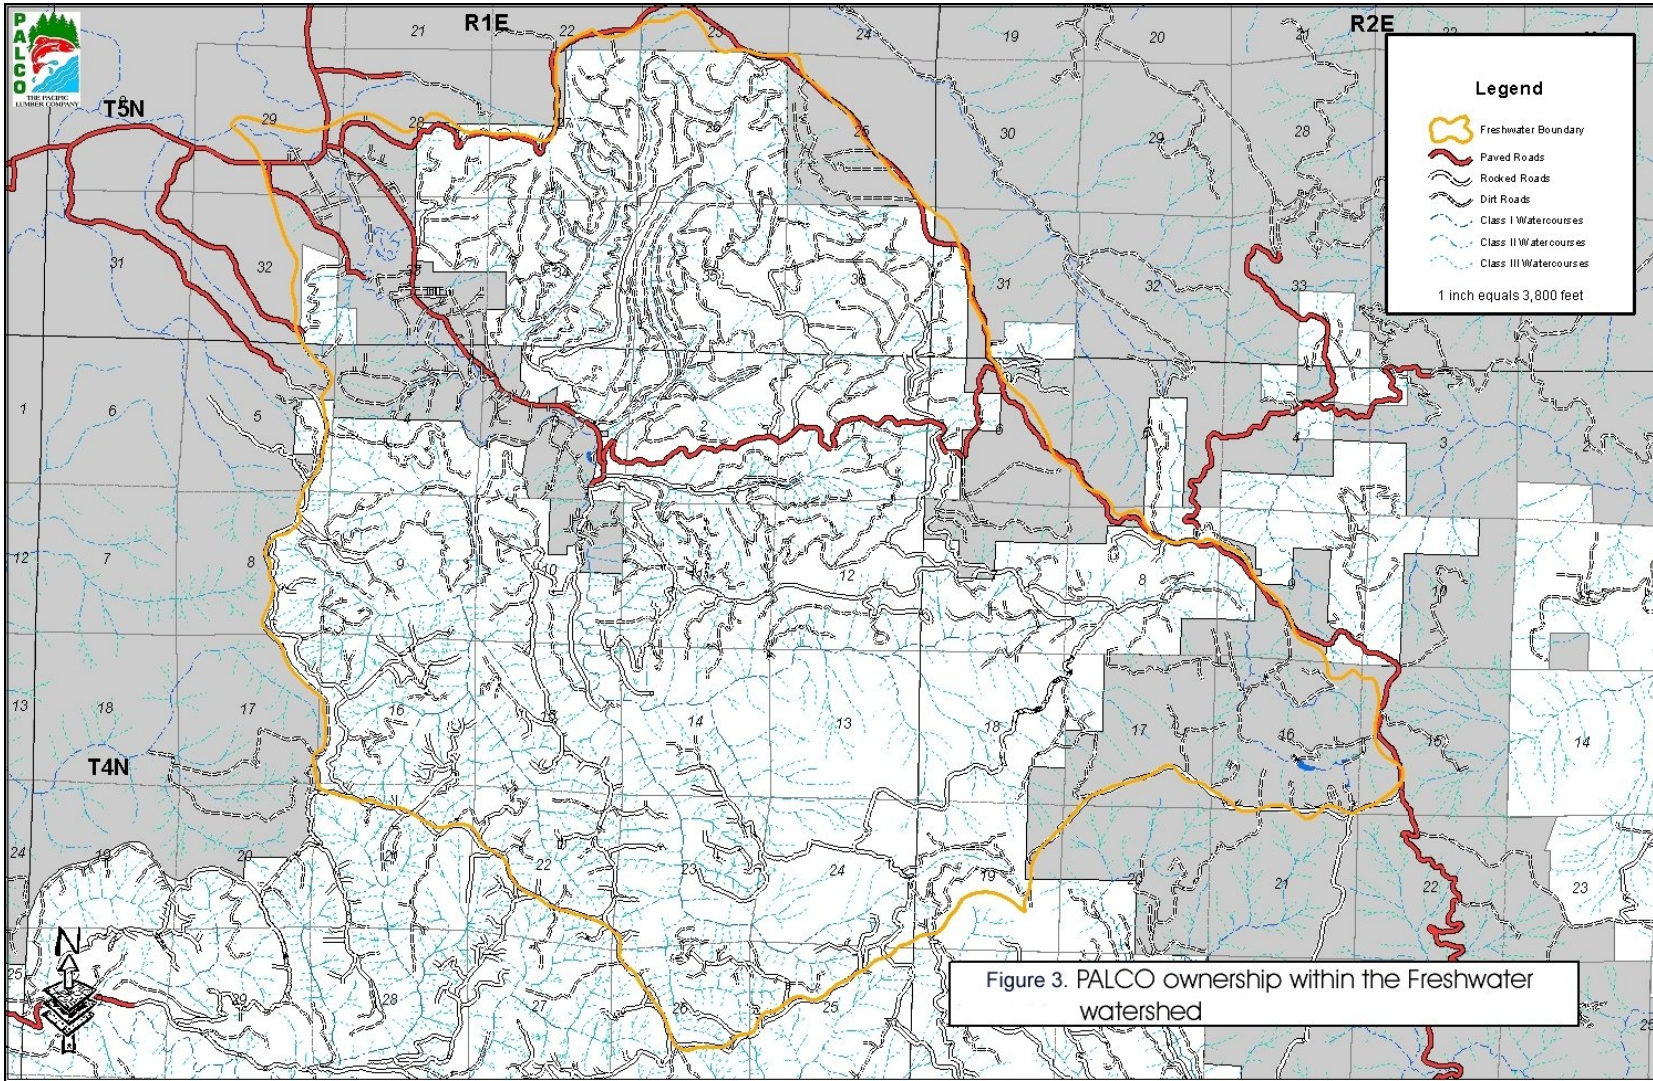
Figure 3: PALCO ownership within the Freshwater Watershed.

Approximately 24 mi² (15,400 acres), or 77% of the watershed, is owned and managed for timber by PALCO (Figure 3). Small private residences and several ranches comprise most of the remainder of the landowners in the basin. A number of small home sites and several large ranches occupy acreage around the eastern perimeter of the watershed in the Greenwood Heights and Kneeland areas. The lower watershed, including most of the Freshwater Creek floodplain and the adjacent terraces downstream from Freshwater County Park and the town of Freshwater, is privately owned by a number of small landowners. Some of the valley side slopes near and downstream from these valley bottom areas are also privately owned.

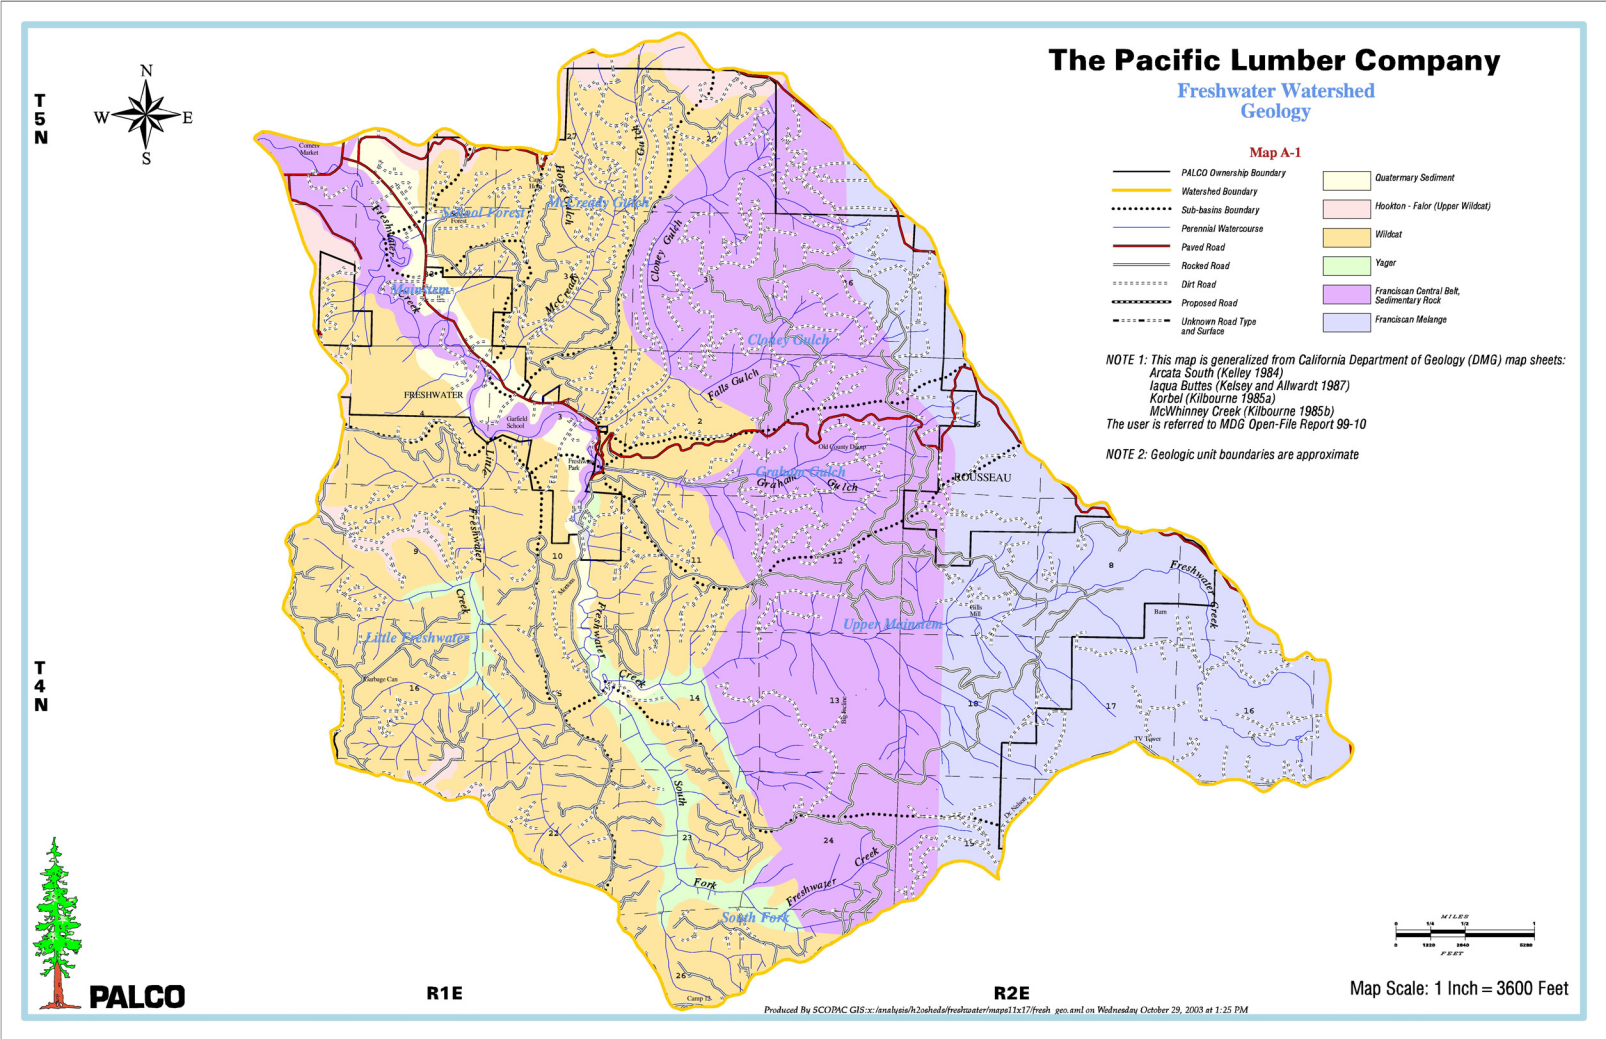
Figure 5: Freshwater Watershed geology.

Sediments and rocks present within the Freshwater Creek Watershed consist of primarily three groups: the Wildcat Group, the Franciscan Central Belt Group, and the Yager Formation (Figure 5). The Wildcat Group is found most extensively in the western 60% of the watershed. This group is composed primarily of mudstone, siltstone, claystone, fine-grained sandstone, and minor conglomerate. Wildcat sediments are both erodible and potentially unstable by nature. Their silty and sandy composition results in rapid weathering and the development of granular, non-cohesive soil materials. Because the sediments are primarily silt- and sand-sized and are geologically young sediments (not indurated into hard rock), they are quite erodible when exposed. Gravels in the streambed that are derived from the Wildcat are typically very soft and can be broken between one's fingers. Hence, they weather quickly into fine materials once in the stream.

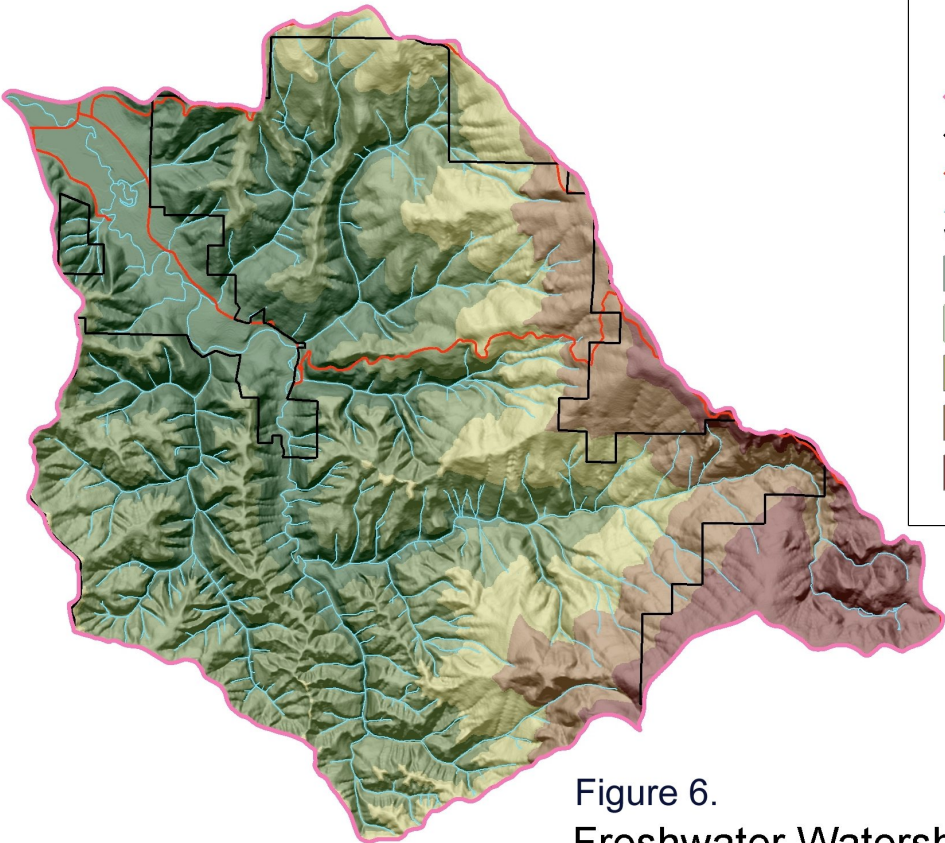
Figure 6: Freshwater Watershed analysis topographic analysis relief map.

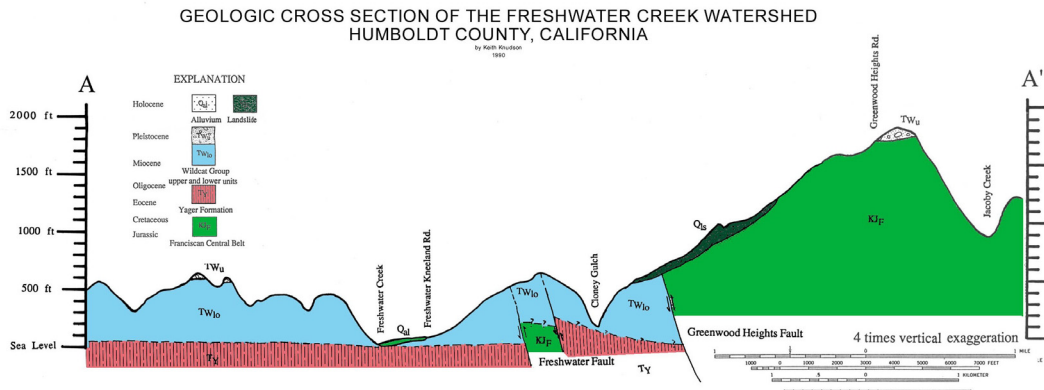
Figure 7: Geologic cross-section of the Freshwater watershed.

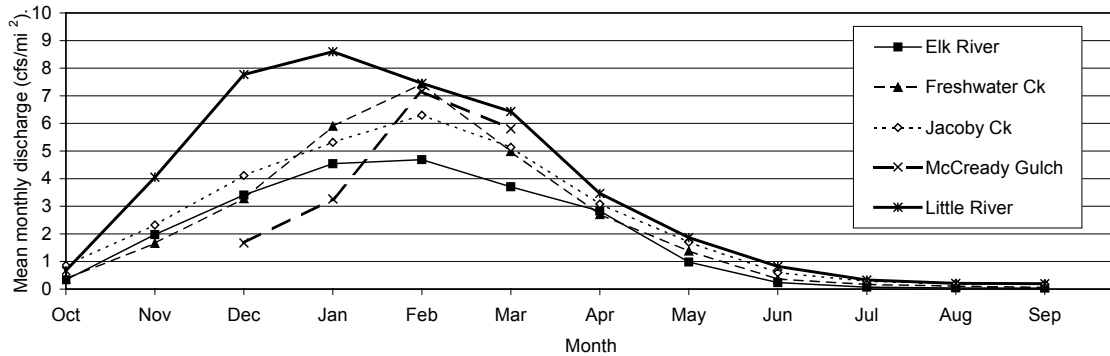
Figure 8: Mean monthly discharge at several stream gages in the vicinity of the analysis area.

Streamflow patterns tend to follow the precipitation patterns, with the greatest flows in winter and spring, and lowest flows in summer (Figure 8). Major storm events were

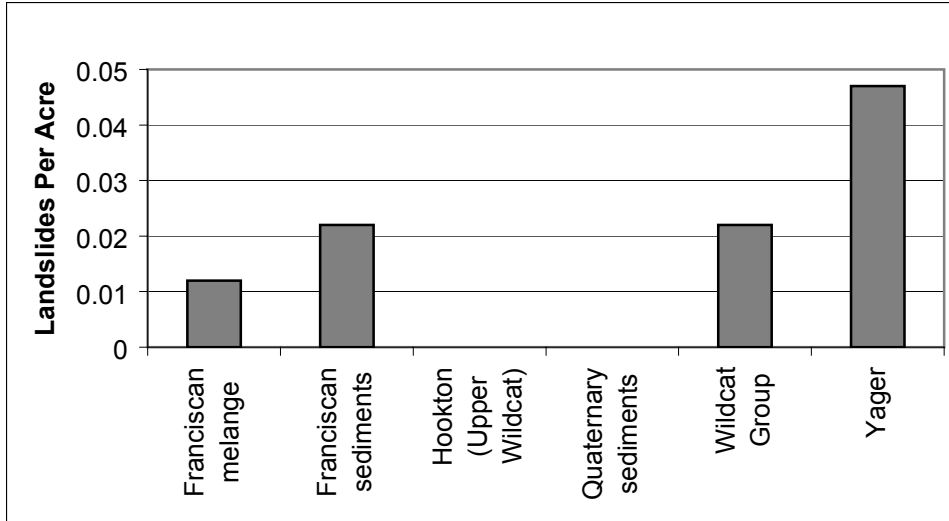
Figure 10: Hillslope landslides per acre by geologic unit.

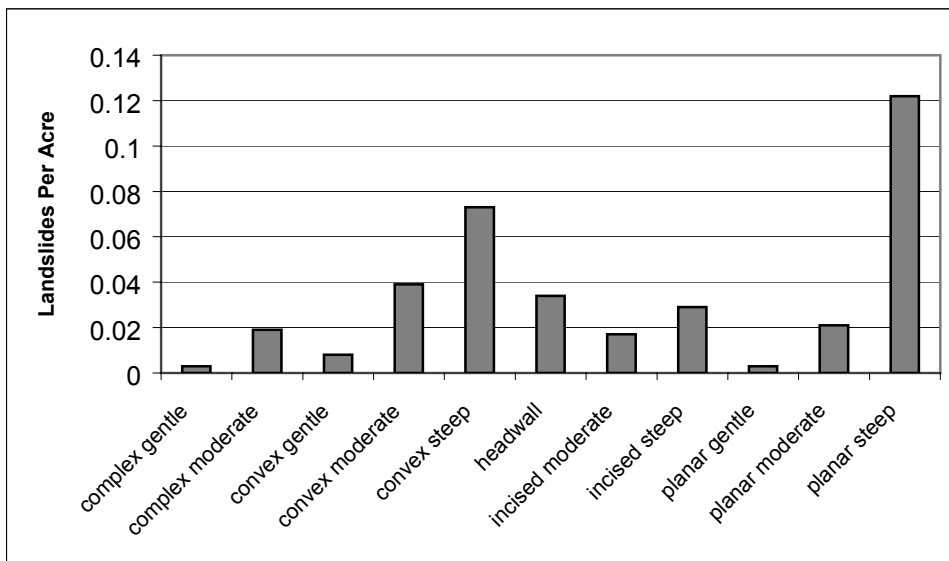
Figure 11: Hillslope landslides per acre by landform/slope class.

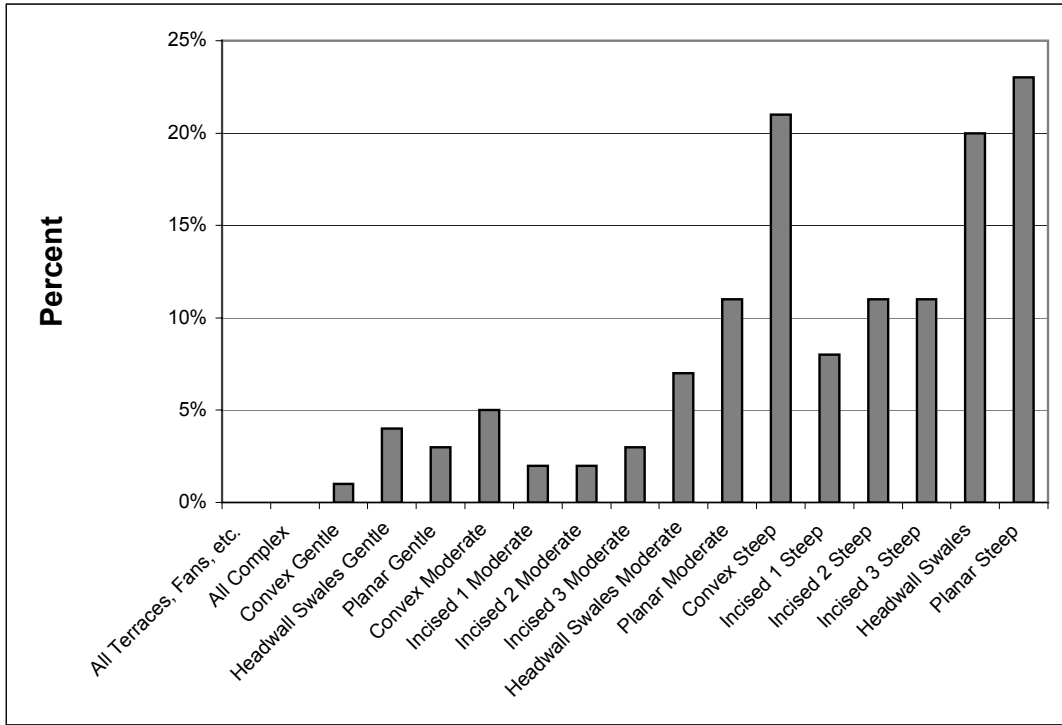
Figure 12: Probability of slides based on the stochastic modeling.

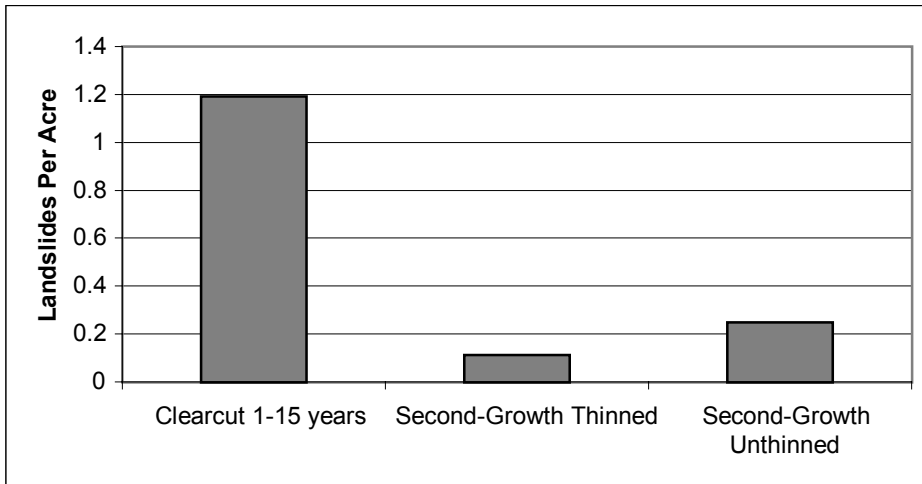
Figure 14: Landslides per acre by management treatment.

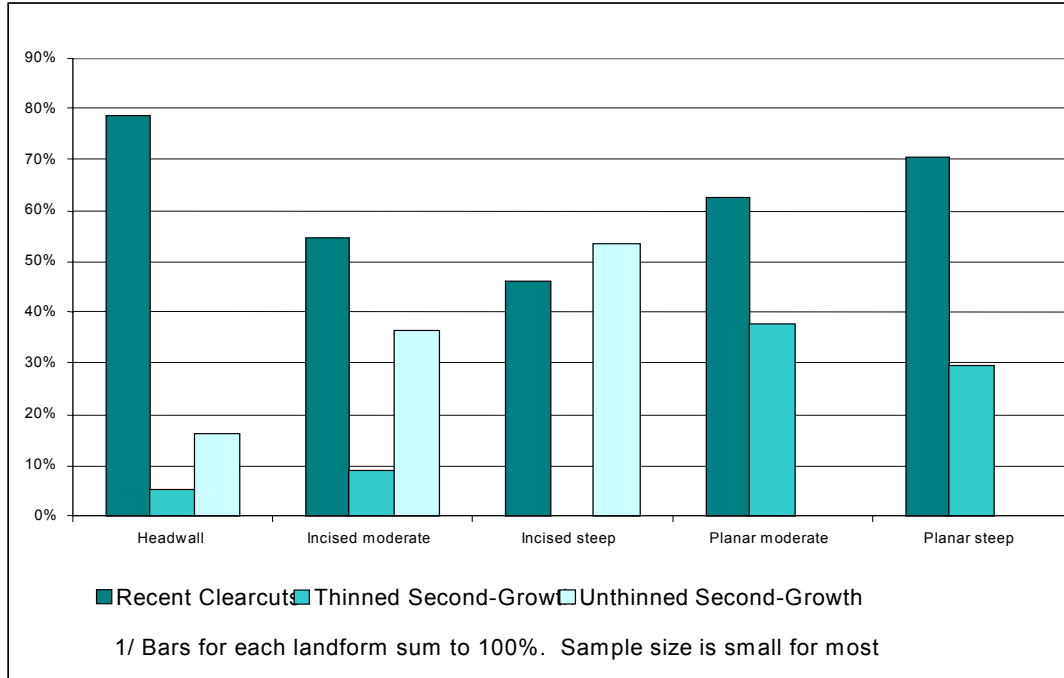
Figure 15: Relative proportion of landslides in each landform by management treatment. Bars for each landform sum to 100%. Sample size is small for most landforms, which significantly affects the results.

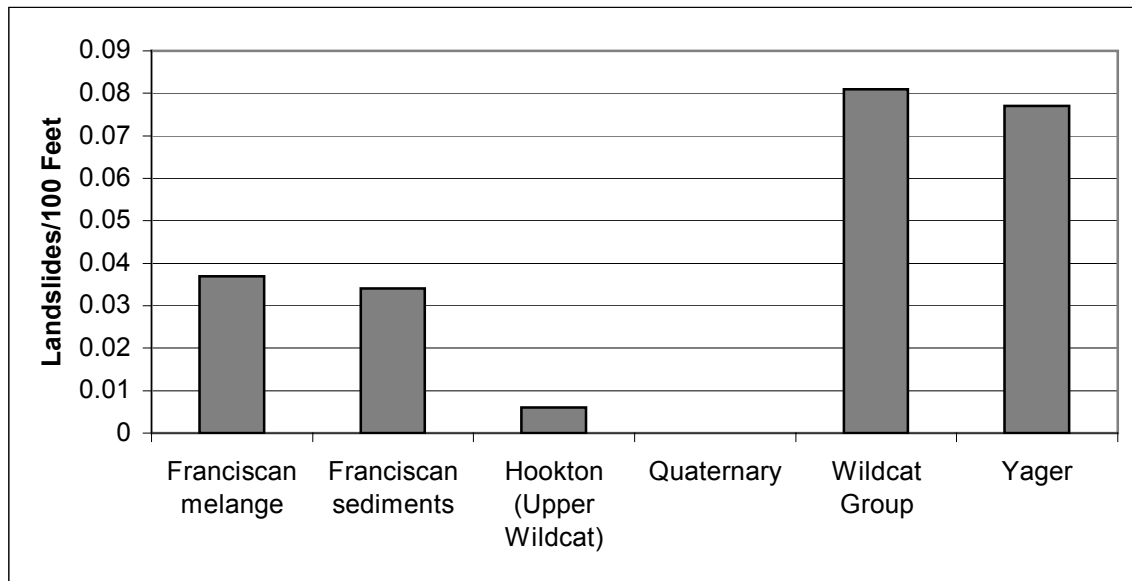
Figure 16: Road-related landslides per 100 linear ft of road by dominant geologic unit.

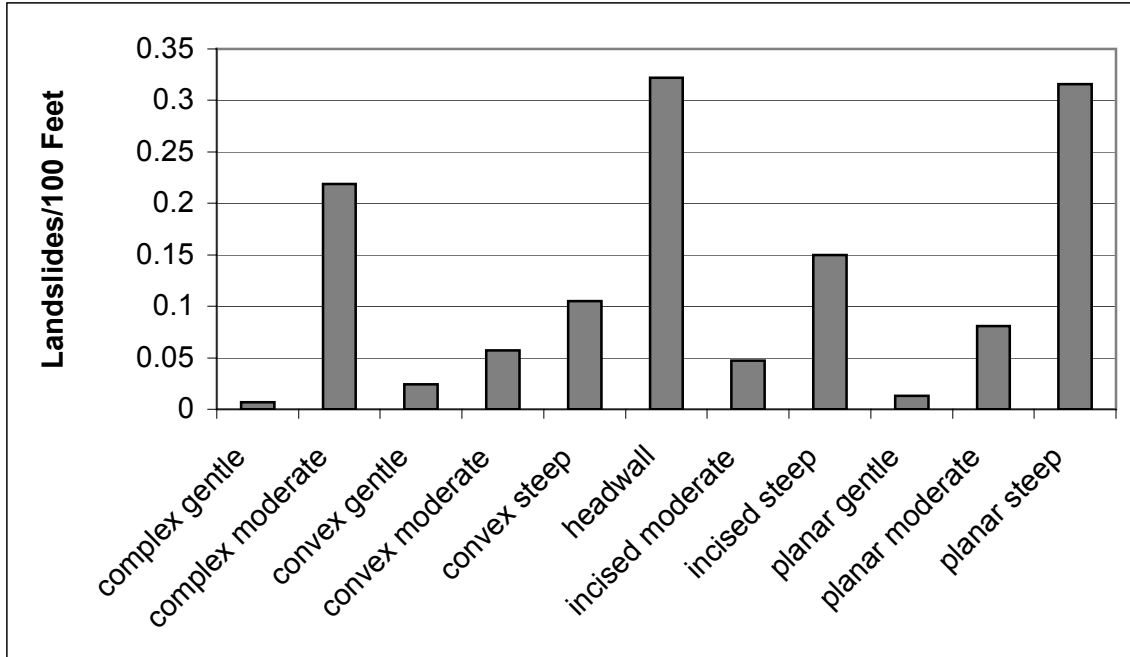
Figure 17: Road-related landslides per 100 linear ft of road by landform/slope class.

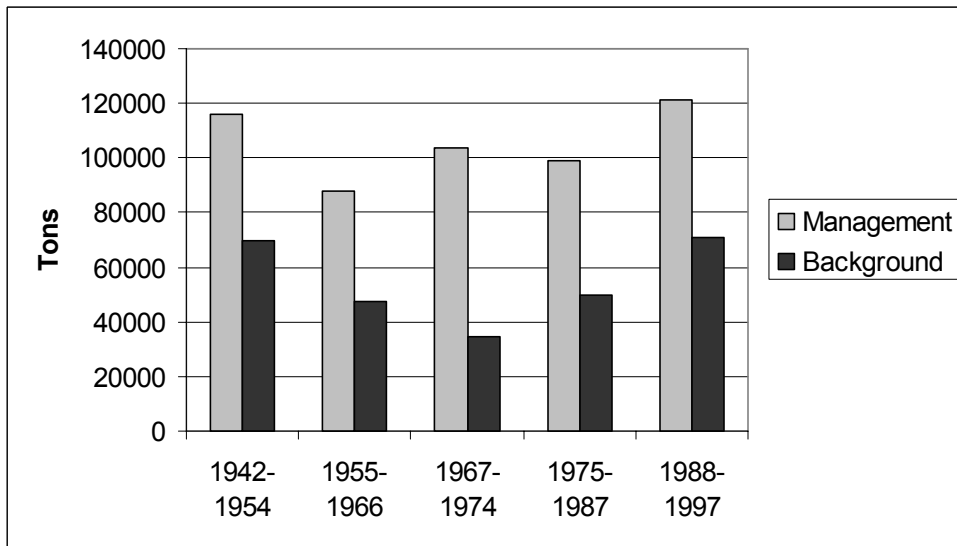
Figure 18: Trend in background and management-related sediment inputs over time. (Note that “management for the period of 1988-1997 includes that portion attributed to legacy inputs in discussions regarding the recent period).

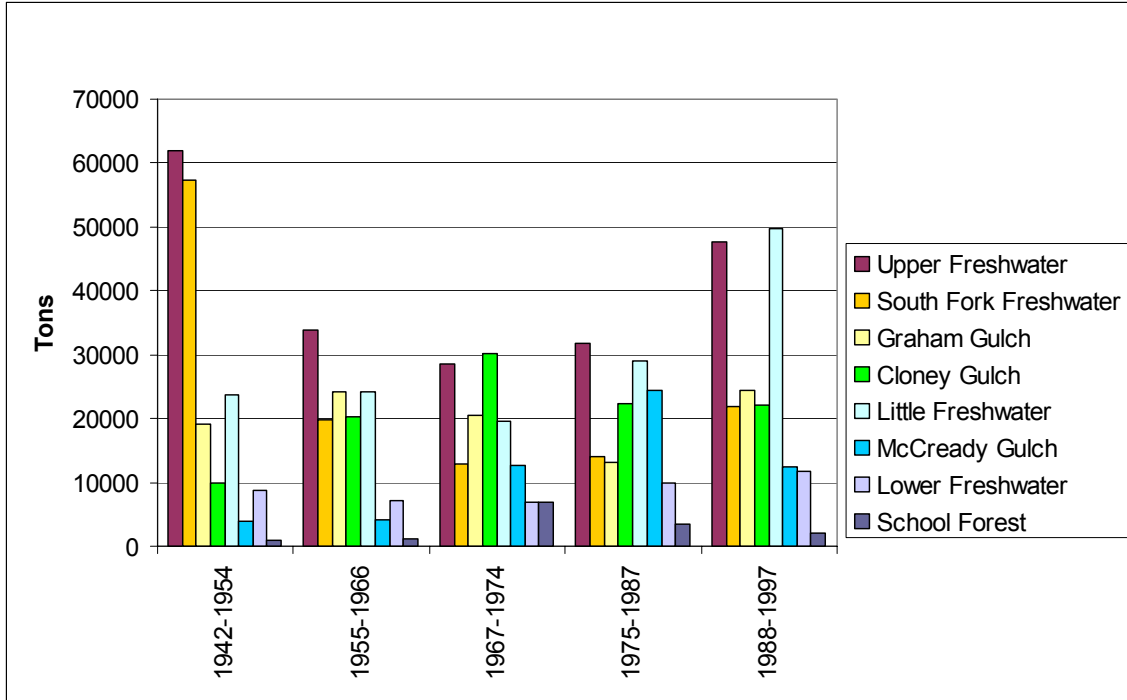
Figure 19: Trends in total sediment inputs by subbasin over time.

Management-related sediment inputs have also been quite variable. The variation in inputs reflects both climatic effects and the extent of management in each subbasin over time. Sediment inputs also varied between subbasins, reflecting local weather effects and management activities (Figure 19, Figure 20). Note that much of the variability in Figure 19 is also due to variations in subbasin size. Figure 20 depicts the same data adjusted for basin size.

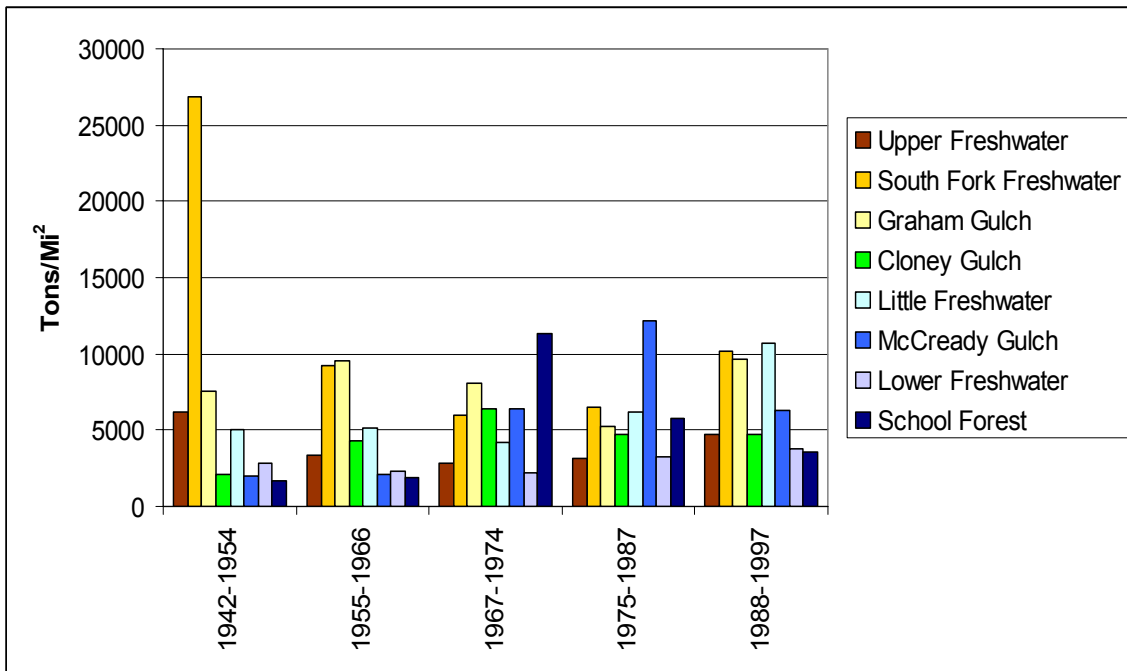
Figure 20: Trends in sediment inputs per square mile over time.

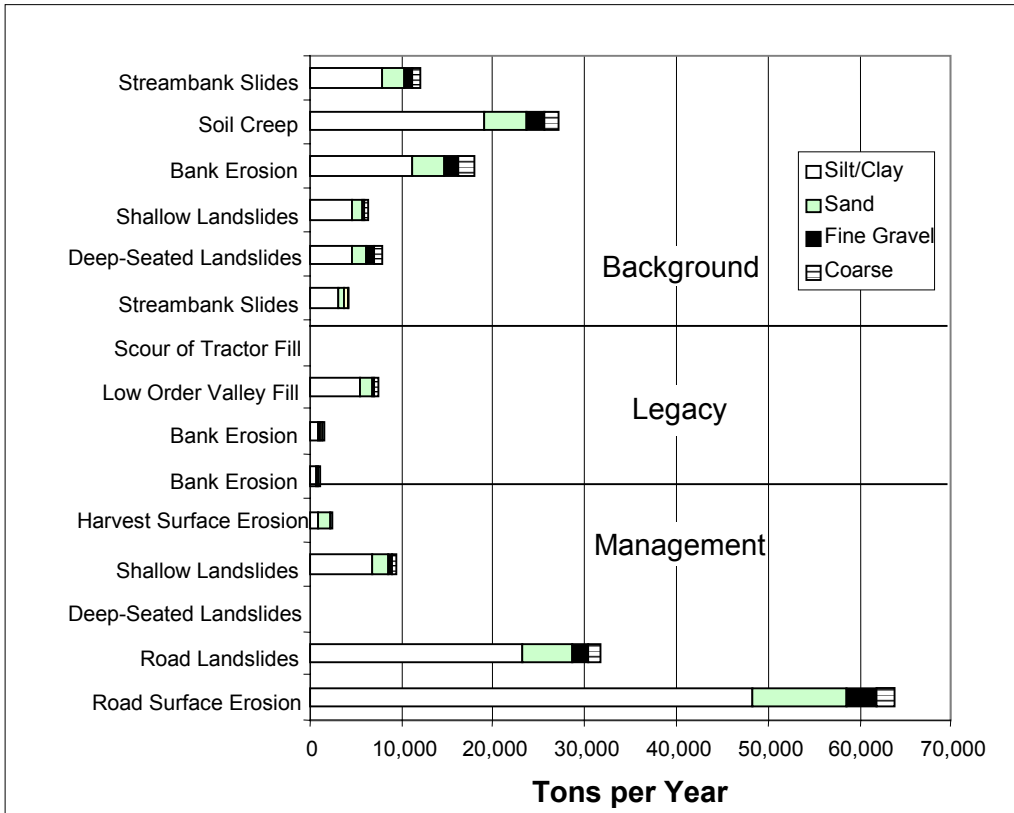
Figure 21: 1988 to 1997 total sediment inputs by source.

In the period from 1988 to 1997, road surface erosion is the largest source of management-related sediment (Figure 21). Sediment inputs generated by road-related landslides contribute roughly half as much sediment as road surface erosion. Shallow landslides also contribute sediment, but this input type is a much smaller portion of the management-related sediment inputs. Basin wide, total management inputs (108,400 tons excluding legacy inputs) in the period from 1988 to 1997 were roughly 1.6 times as high as natural background inputs (71,108 tons).

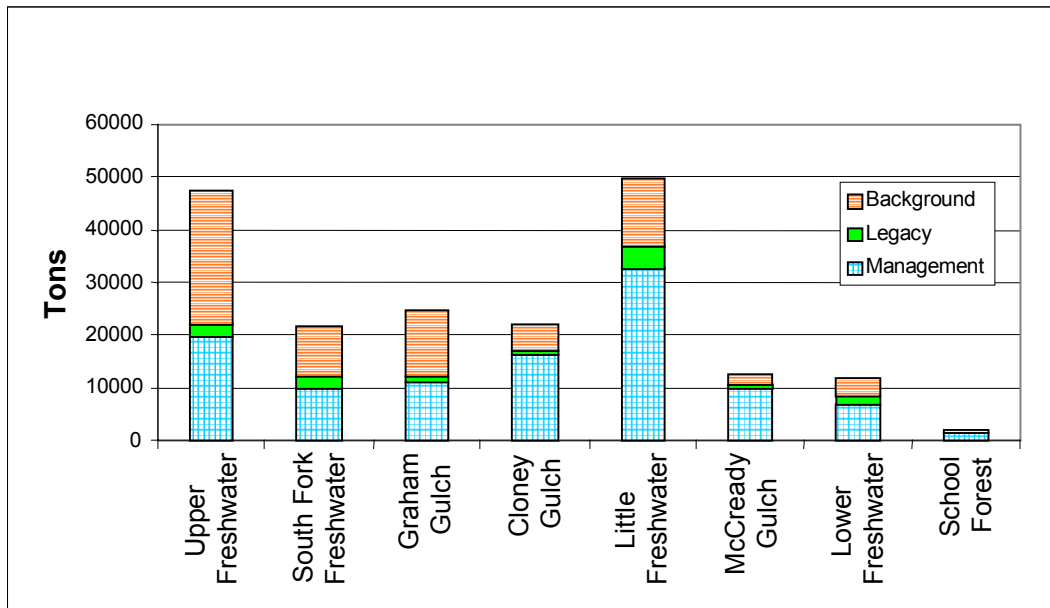
Figure 22: Total Sediment Inputs by Subbasin, 1988-1997.

The majority of the sediment inputs in the period from 1988 to 1997 originated in the Upper Freshwater and Little Freshwater subbasins, the two largest subbasins (Figure 22). Cumulatively, road surface erosion was the largest contributor of management related sediment in all subbasins except the Little Freshwater, where sediment input through road related landslides exceeded the road surface erosion inputs (Table 4-4). Road surface erosion constituted roughly 60% of all management related sediment input basin wide.

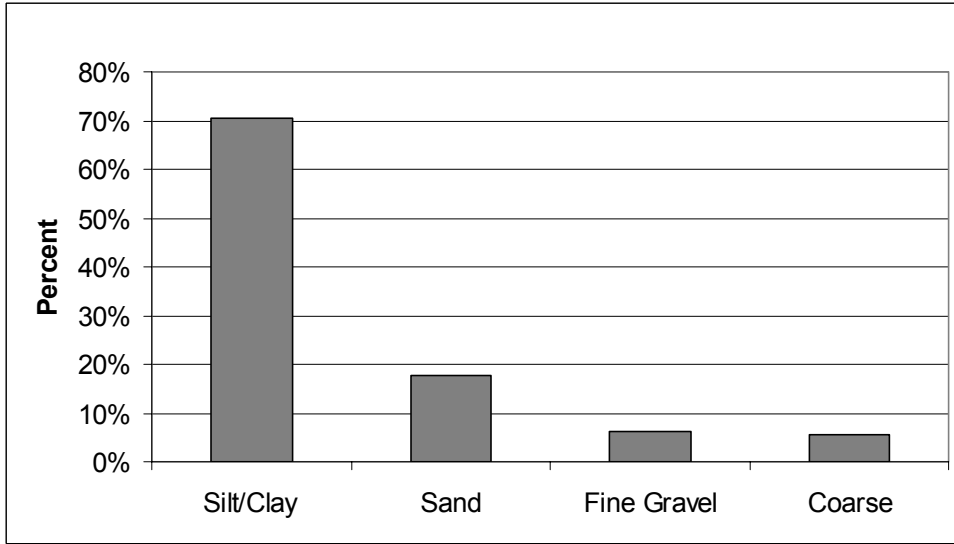
Figure 23: Grain size of sediment inputs in the Freshwater Watershed.

Fine-grained sediments (<2 mm) tend to remain suspended and contribute to turbidity of water. Coarser grained sediments (>2 mm) are likely to settle out in the channel bottom, although they may at times be carried in suspension, depending on the stream power (which is a function of the gradient of the stream and the magnitude of flow).

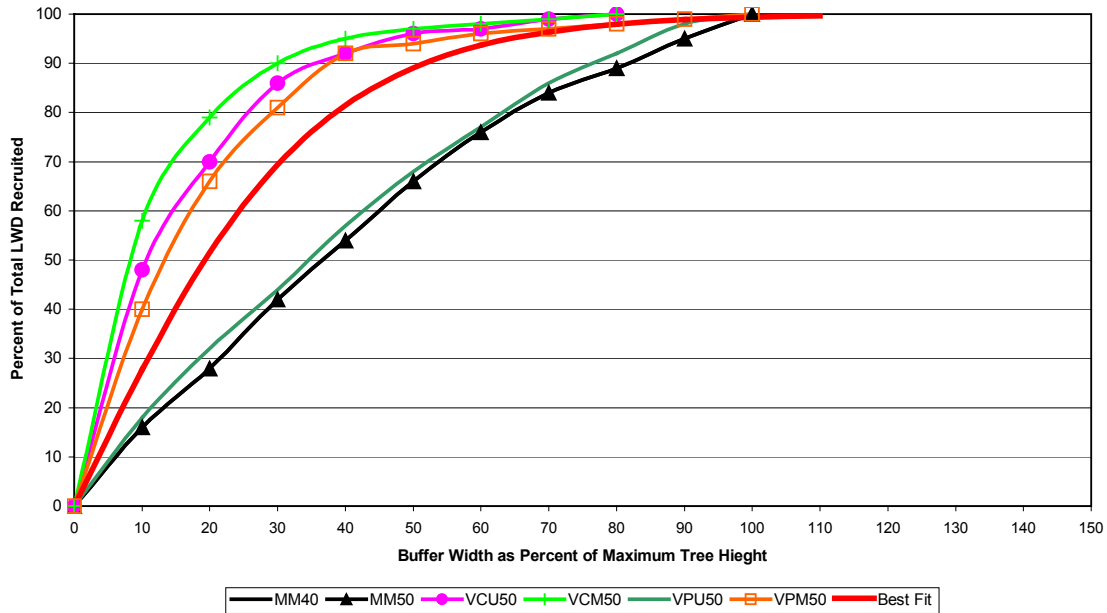
Figure 25: Source distance curves for modeled (theoretical) data. See the Riparian Condition Module Report for further explanation.

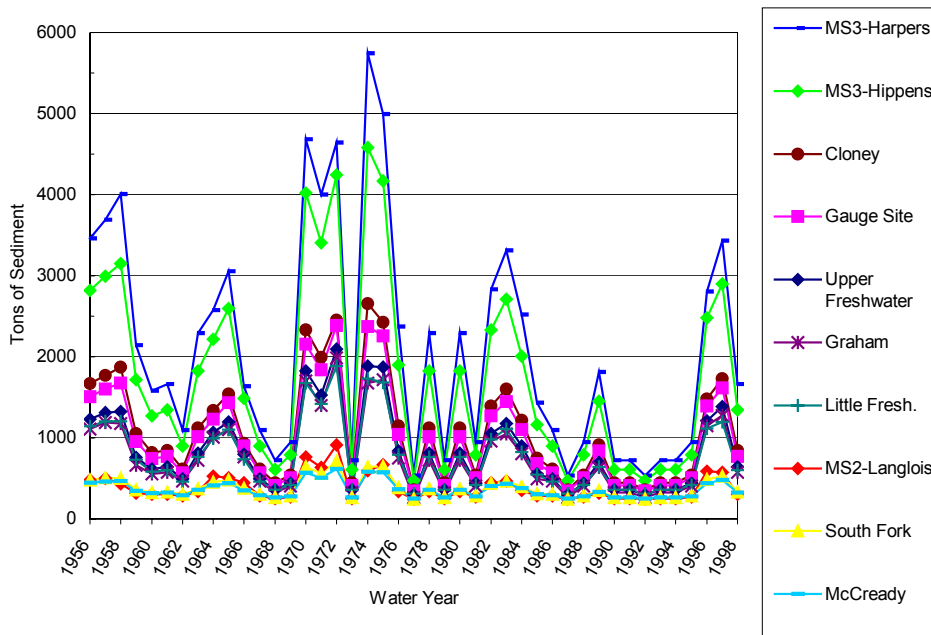
Figure 27: Modeled bedload sediment transport capacity over time for Freshwater subbasins and mainstem reaches (based on flow record at Little River).

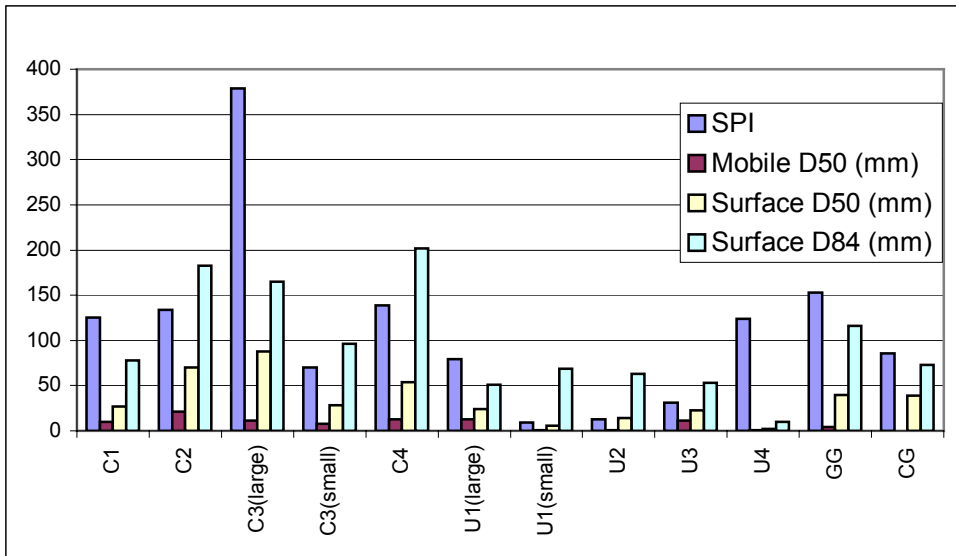
Figure 28: Summary of the range of values of d50 and stream power indices for CGU groups.

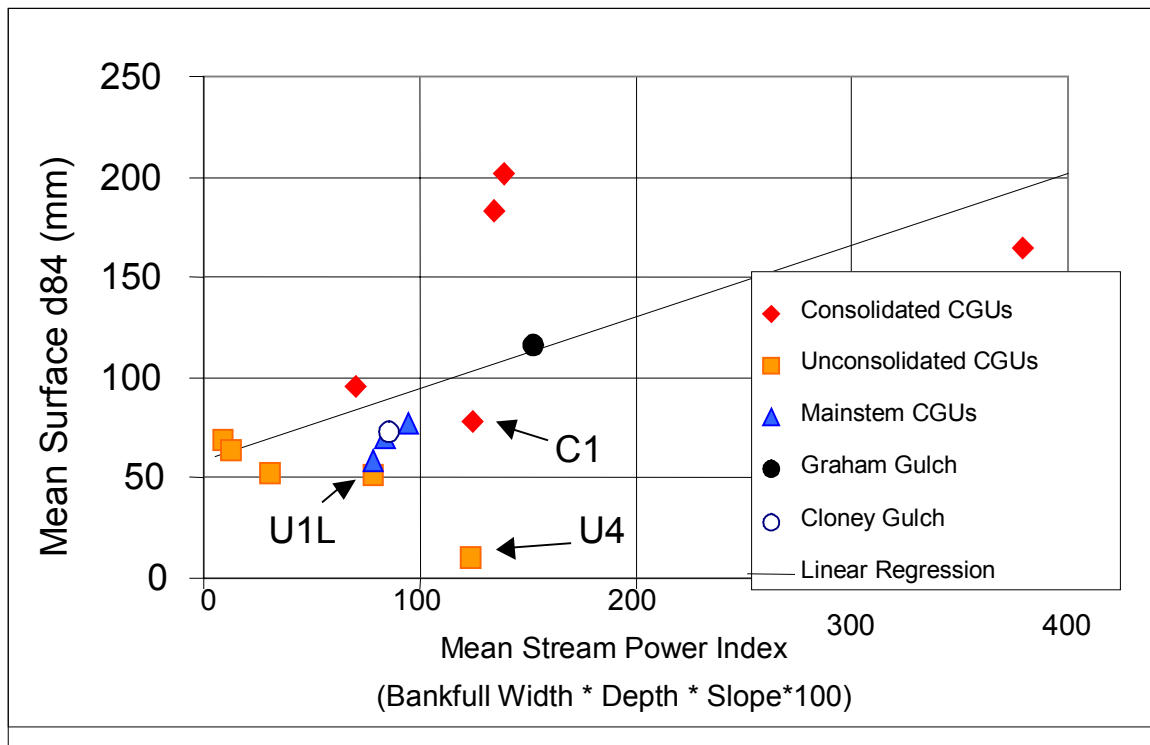
Figure 29: Plot of mean surface d84 for CGUs versus mean stream power index for each CGU.

Deposition of sediments is related to the transport capacity of the channel and the total inputs of sediment relative to the transport capacity. The grain size of existing and input sediment is also a factor in whether sediments deposit or are carried farther downstream. The unconsolidated CGUs tend to have smaller particle size than the consolidated units (Figure 28). In general, the mean surface d_{84} (mm) correlates with mean stream power index (Figure 29).

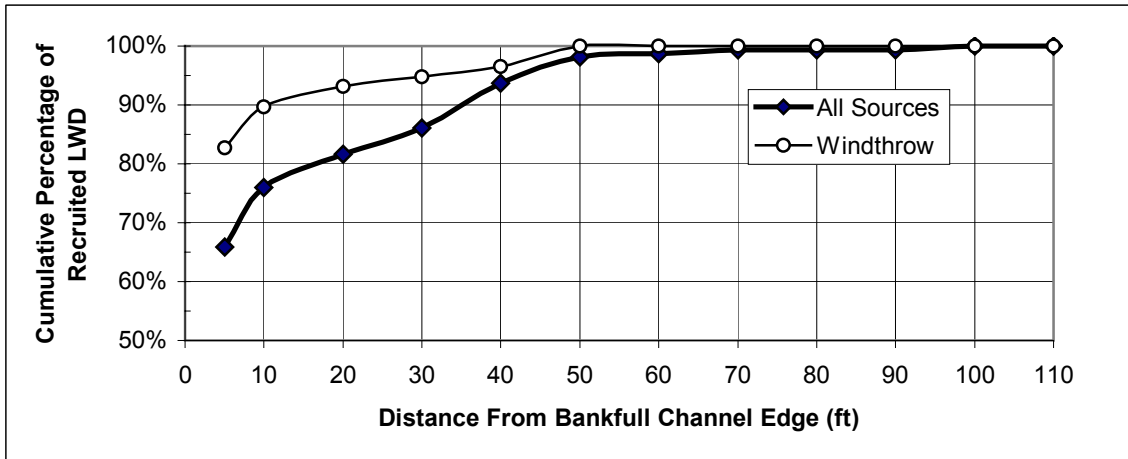
Figure 31: Cumulative percentage of LWD pieces recruited as a function of distance from the channel edge.

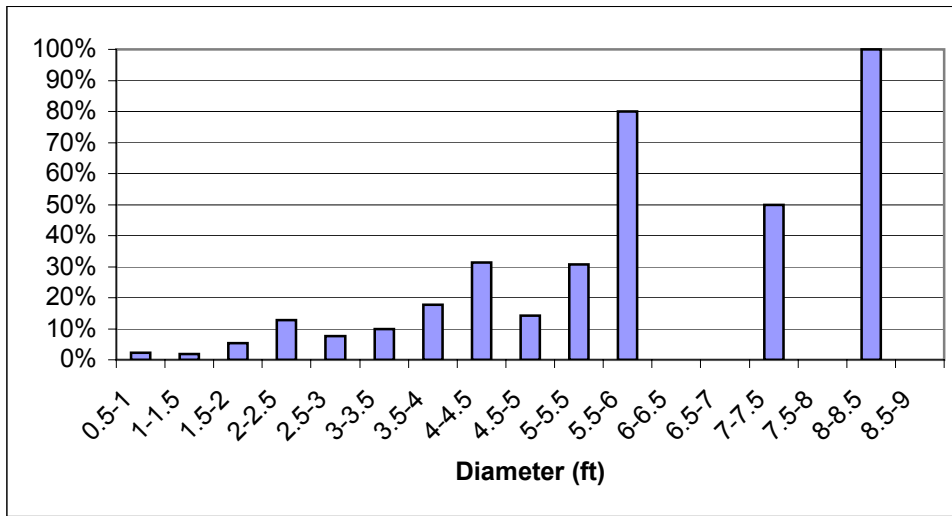
Figure 32: Percent of pieces of wood by size class that formed pools.

The effectiveness of wood in forming pools tends to increase with the size of wood (Figure 32). However, the majority of pools in the watershed were formed by wood that was 1.5 to 2.5 ft in diameter, indicating that wood this size is very functional in most of these streams (Figure 33). This size wood is similar to the minimum size defined by Fox in the PFC matrix, indicating that the Fox target for piece size is appropriate.

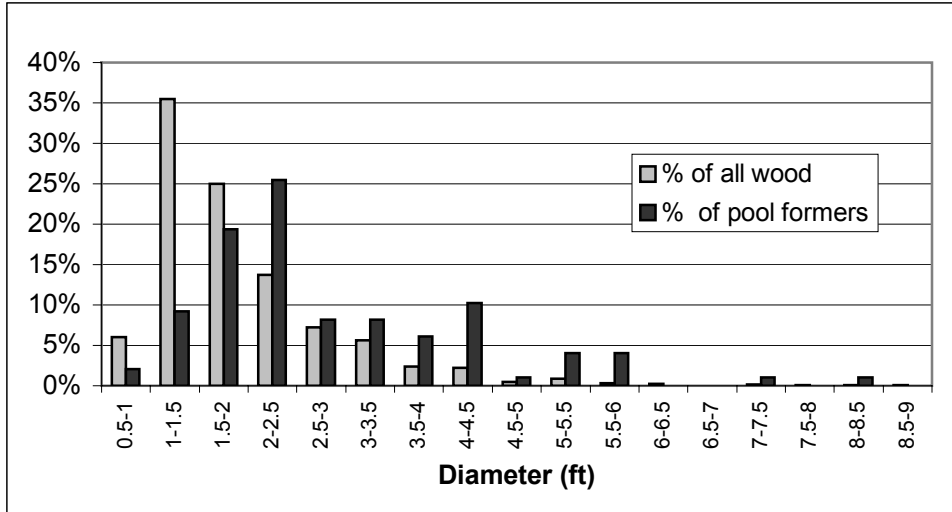
Figure 33: Percent of pieces of wood by size class present in the watershed and percent forming pools by size class.
