Freshwater Creek Watershed Analysis Final Report

**Pacific Lumber Company (PALCO)
Scotia, CA**

Watershed Professionals Network

December 2003

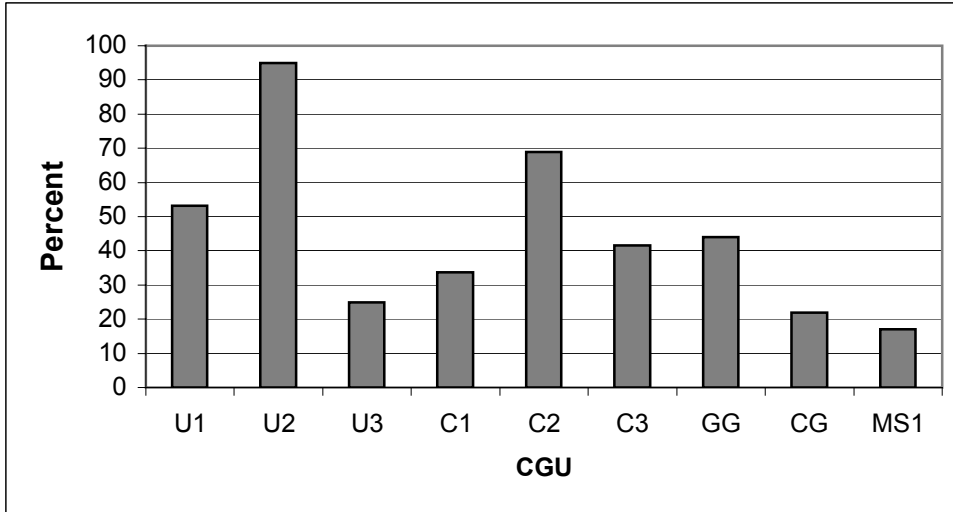
Figure 34: Percent of pools formed by LWD.

The data indicate that fair to good conditions exist for summer rearing by salmonids in the watershed. Pool area and frequency meet properly functioning condition target levels in most areas. Wood is the primary factor affecting the development of pools. Overall, a substantial number of the pools in the surveyed reaches were wood formed (Figure 33). A larger percentage of pools were formed in the moderate gradient channels (U2 and C2) than in the very low gradient and higher gradient channels (Figure 34). This is consistent with observations seen elsewhere. Pools in very low gradient channels often form at meander bends as a result of scour. Hence, some pools will form in the absence of wood (see MS1, which has very low wood abundance). In higher gradient channels, bedrock controls and rocks often serve as the roughness elements for pool formation. In these channels, however, larger pool forming boulders are scarce, particularly in streams flowing over Wildcat geology. Hence, wood plays an important role in habitat formation.

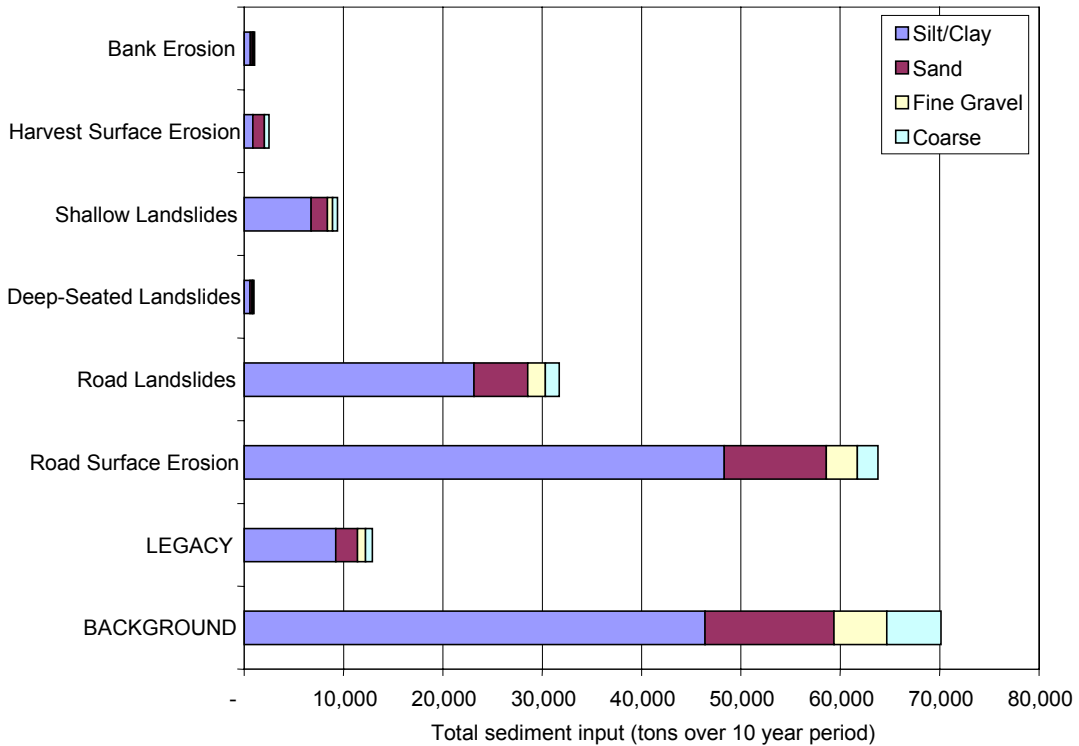
Figure 35: Sediment input to Freshwater Watershed from different sources, 1988-1997.

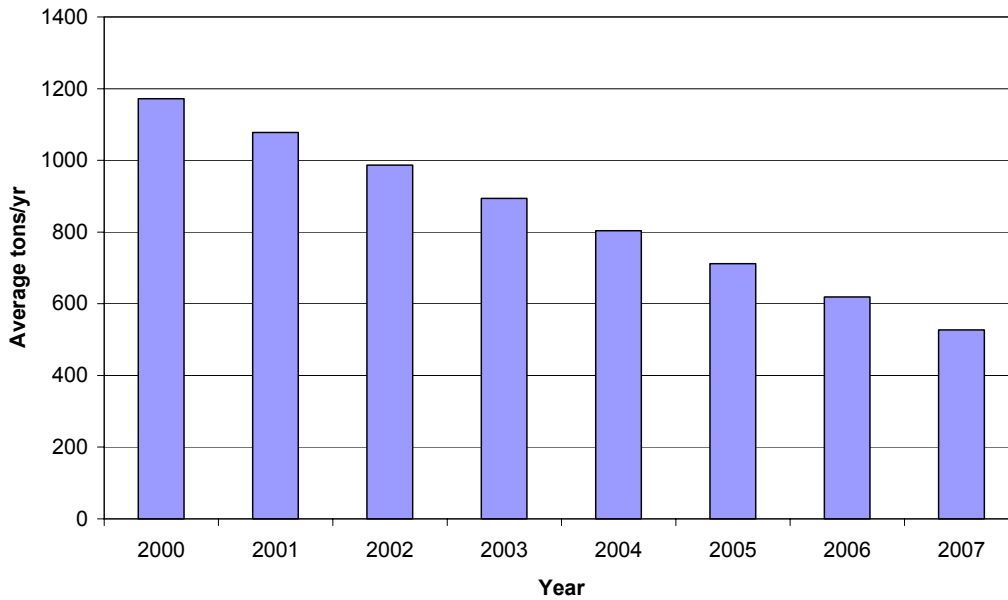
Figure 36. Total Harvest Landslide Inputs.

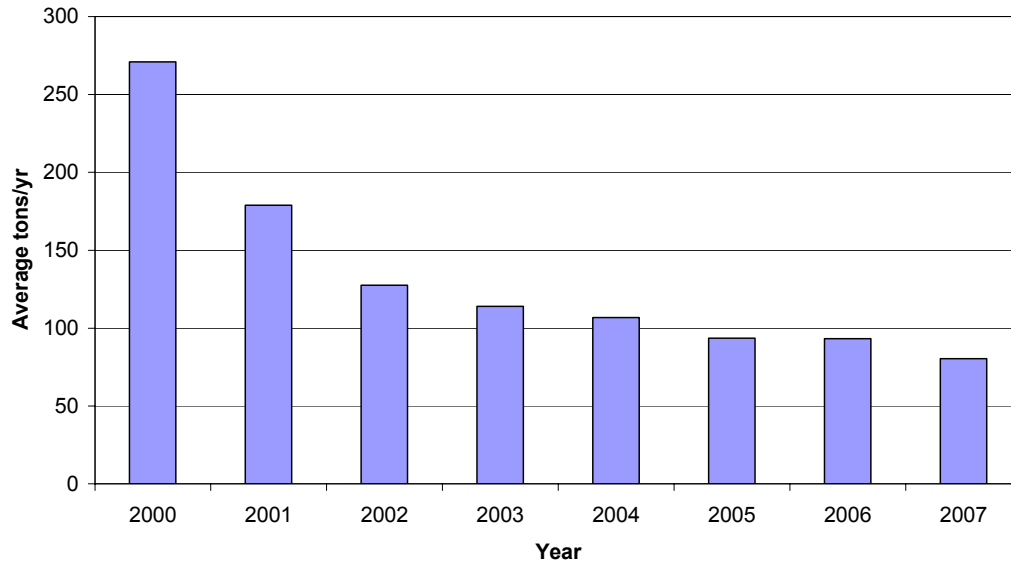
Figure 37. Harvest surface erosion inputs from 1988-99 harvest.

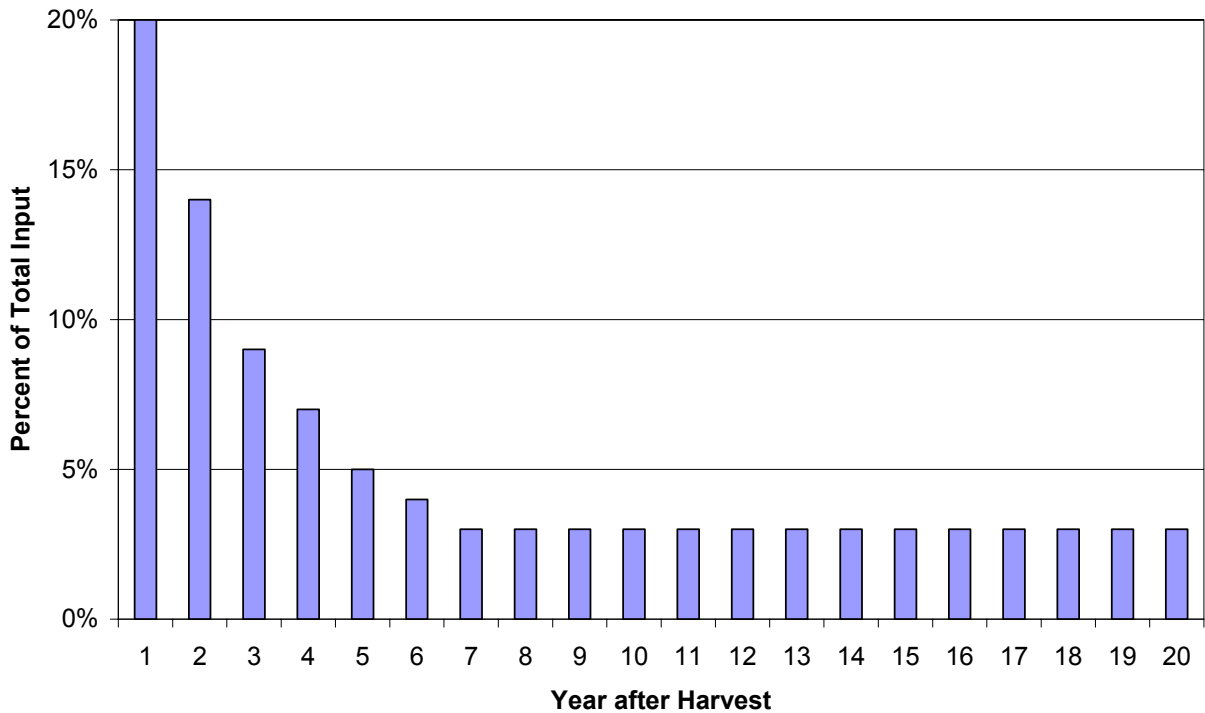
Figure 38. Distribution of future WEPP inputs.

Harvest surface erosion from new/proposed THPs will be calculated using a GIS-based WEPP analysis similar to that used for the watershed analysis. The total input will be distributed over 20 years using a distribution similar to the average annual distribution from the watershed analysis computations (Table 5-10 and Figure 38).
